WJD Decker
Home Services, LLC

Inspection Report

**Property Address:
1234 5th St
Anytown, IL**

| Date: 6/10/2008 | Time: 10:30 AM | Report ID: Sample Large |

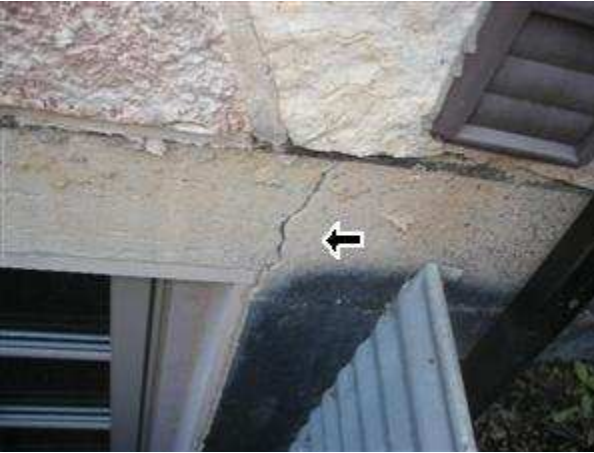
1.0 Picture 1

Foundation was poured concrete with some minor exterior signs of cracking but no efflorescence or water intrusion where observed. Interior inspection was limited because of wall finishing in basement, but there were no signs of staining in the finished portion, nor signs of water staining or intrusion in the observable portion. There were some minor settling cracks seen in the unfinished portion of the basement that was located under the garage and on the exterior radiating from the corners of the basement window frames (Picture 1). These type of foundation cracks are normal and are a result of the normal settling process.

1) WL - The foundation wall exhibits some small vertical cracking. Recommend that these cracks be monitored for movement. Once movement has stopped, recommend that the cracks be sealed by urethane injection as a guard against seepage.

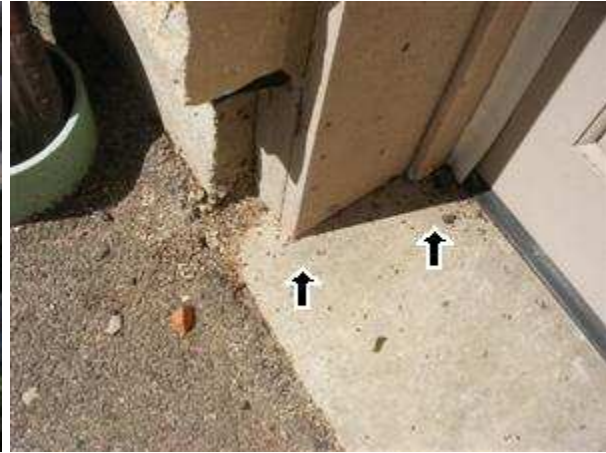
1.0 Picture 2

It should be noted that there was evidence of carpenter ant activity at the garage door lower corner areas (Picture 2) and at the corresponding area in the basement under the garage (Picture 3). Carpenter ants do not "eat" wood, like termites do, but merely burrow into the wood to live there. These insects can be easily dealt with by doing bi-annual perimeter spraying.

2) RR - Recommend evaluation of carpenter ants by a licensed and insured pest contractor.

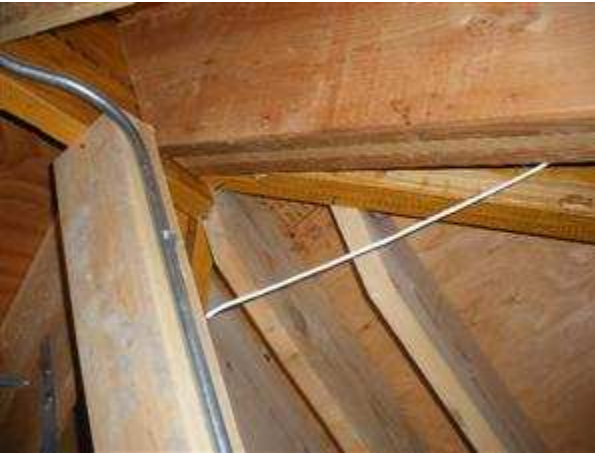
1.6 Picture 1

The roof structure, as observed from the accessible portion of the attic, was stick built with 2 x 12 wooden rafters and large laminated hip rafters (Picture 1) with a large laminated ridgeboard. The roof decking was exterior grade plywood. The roofing members displayed no signs of water staining or displacement. There was some minor evidence of "honeying" which is indicative of elevated temperatures in the attic, but this was minor. Moisture readings of the rafters and roof decking were within normal limits.

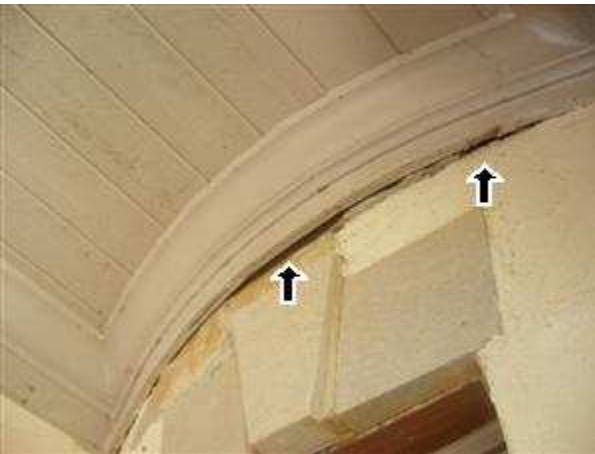
2.0 Picture 3

There was a small area, located at the front porch, where the exterior wall should be caulked to the ceiling area (Picture 3).

2) RR - Recommend that the small area of wall / ceiling interface over the front porch be caulked as a guard against water and cold air intrusion.

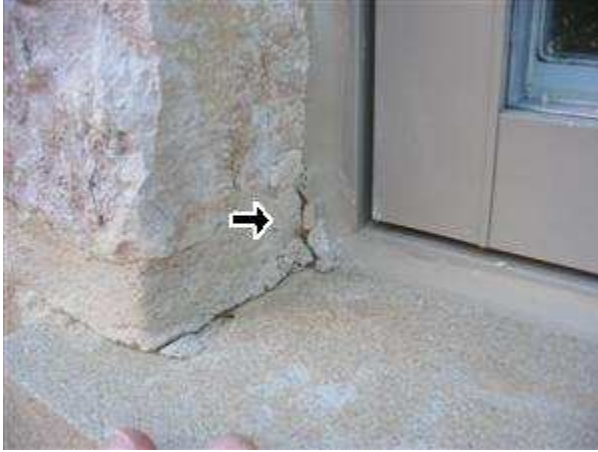
2.3 Picture 1

Exterior window frames were metal clad and displayed no signs of rust or physical damage. The condition of the wood under the cladding could not be determined. There were some small areas where the window caulking was cracked (Picture 1) and should be re-caulked. The steel lintels

1) WL - Recommend that the window exteriors, where they meet the enclosure window frames, be checked semi-annually (fall and spring) for signs of cracking of the caulk and that any such cracks be properly caulked with a good quality, exterior grade, commercial elastomeric caulk.

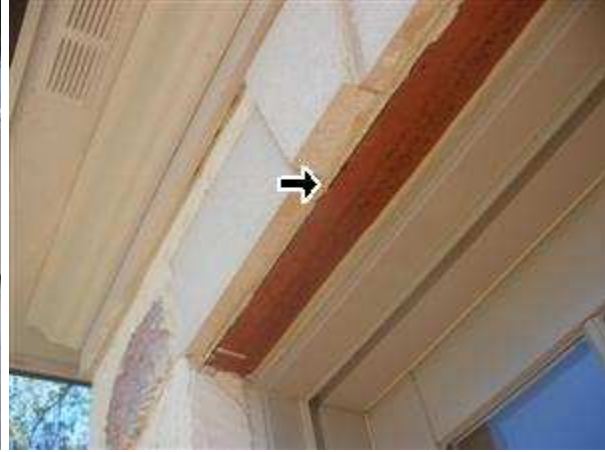
2.3 Picture 2

over the windows were not primed and painted (Picture 2).

2) RR - Recommend final priming and painting of the steel window and door lintels with a good quality, exterior grade metal paint as a guard against the lintels rusting.

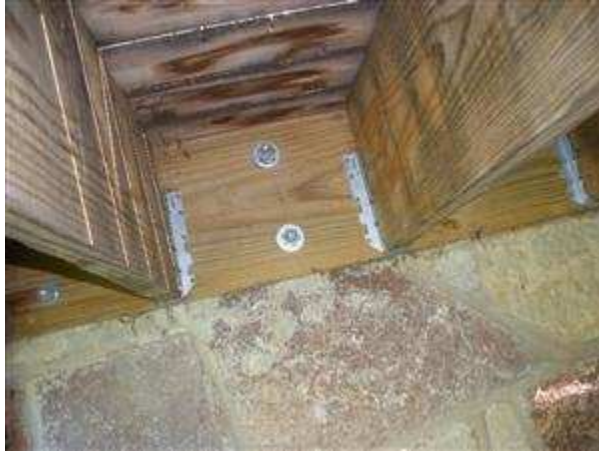
2.7 Picture 1

The rear of the house is equipped with a wooden deck. The deck appeared to be solid, properly secured to the ledger board at the house wall (Picture 1) and displayed no signs of wood rot or structural looseness. The deck support posts were properly footed in concrete (Picture 2).

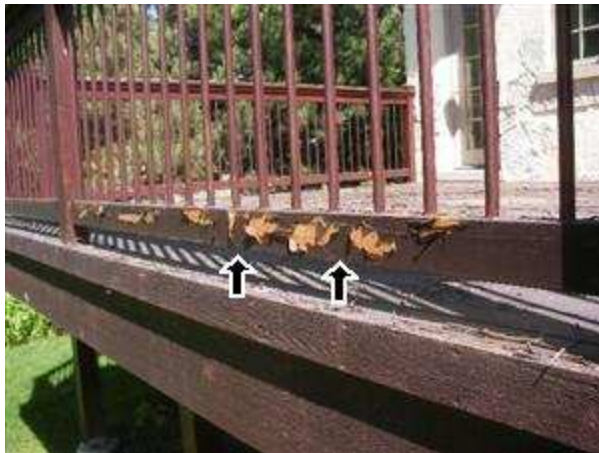
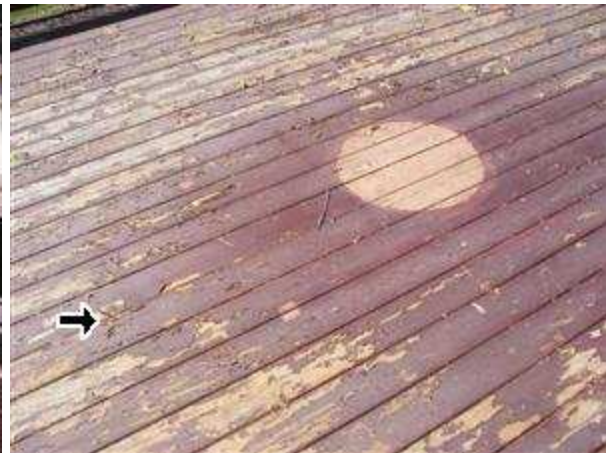
Both the balcony and the deck displayed signs of flaking stain (Picture 3) and the deck surface stain was deteriorated (Picture 4).

1) WL - Recommend that the wood of the porch be treated with a wood sealant as a guard against deterioration.

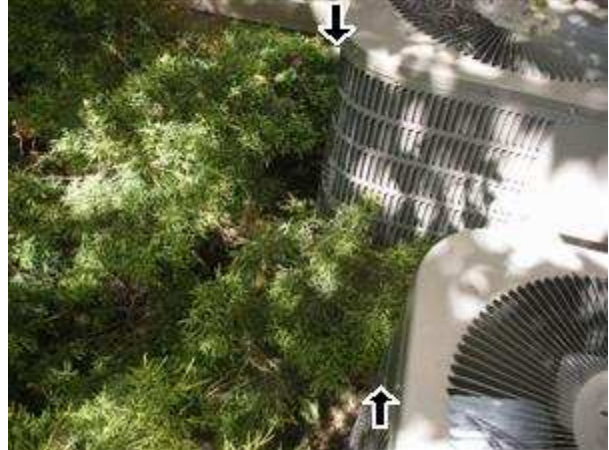
2.10 Picture 2

have its branches trimmed as a guard against damage to the stucco wall. There was also some overgrown plants that were partially blocking the proper ventilation of the A/C compressors (Picture 2).

- 1) RR - Recommend that tree branches brushing the side of the house be trimmed back.
- 2) RR - Recommend that the vegetation growing around the A/C compressors be cut back.
- 3) WL - Recommend that the retaining wall on the east side of the house be monitored for signs of movement. If this wall continues to lean, recommend that it be evaluated and repaired by a licensed and insured masonry contractor.

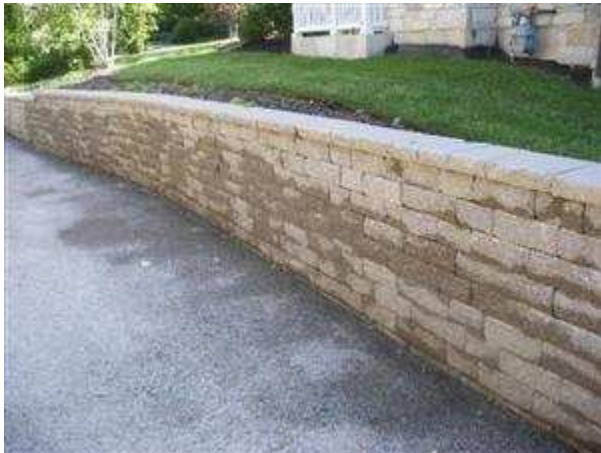
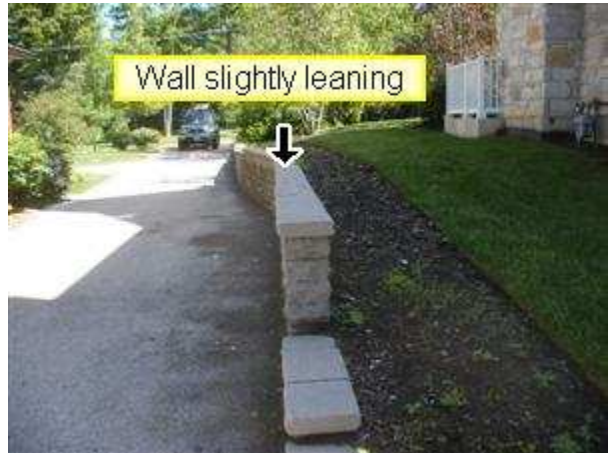
There is a retaining wall on the east side of the house (Picture 3). It appears to be slightly leaning towards the driveway (Picture 4) and it did not appear to be secured properly.

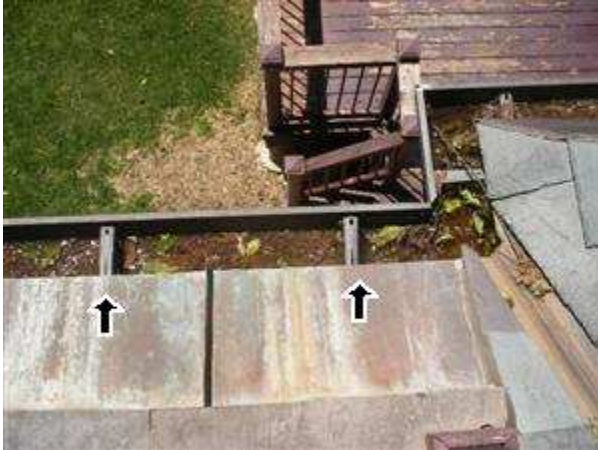
3.2 Picture 1

The roof is drained by means of metal gutters that are secured to the fascia boards by means of metal hangers (Picture 1). The spacing of the gutter supports meets the modern standard of a maximum of 18" spacing between supports. The gutters displayed no signs of rust or physical damage and appear to be properly sloped. The gutters were clogged by leaves and should be

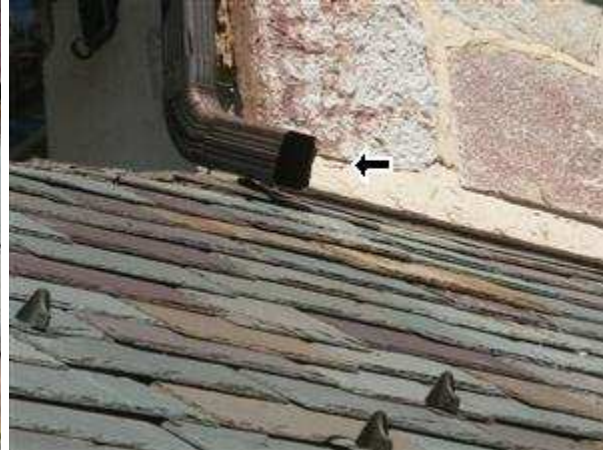
3.2 Picture 2

There are areas where the upper sections of the gutter system drain directly onto lower roof surfaces (Picture 2). This will cause accelerated deterioration of the roof surface under these areas and greatly decrease the life of the roof. This condition will also violate the warranty conditions of most roofing material manufacturers.

- 1) RR - Recommend that all downspouts that drain an upper section of roof terminate either into a lower roof section gutter or to the ground, directly as a guard against excessive water buildup and accelerated roof failure. Recommend evaluation and repair by a state licensed and insured roofer.
- 2) RR - Recommend that the downspout connection to the underground drain pipes be secured with the proper adaptor as a guard against out splashing of rain water.

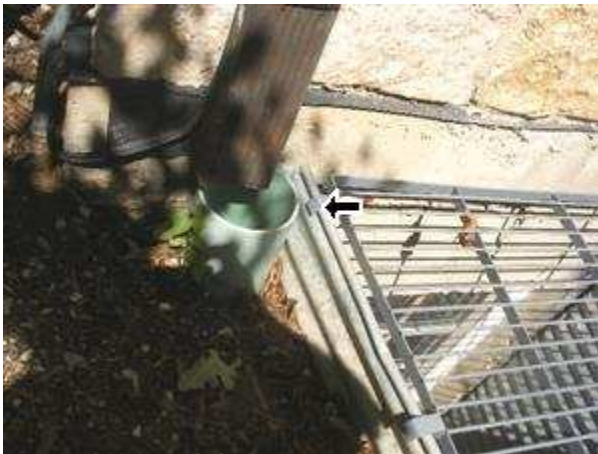
3.2 Picture 3

The downspouts were drained to underground drain piping. There were some areas where the downspouts were not properly connected to the underground drains and there was some evidence of out splashing (Picture 3).

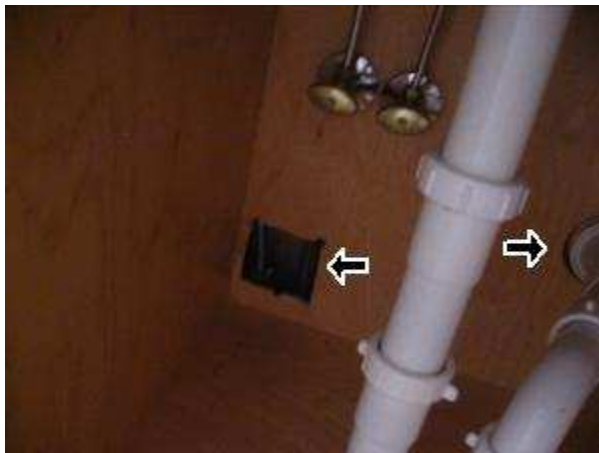
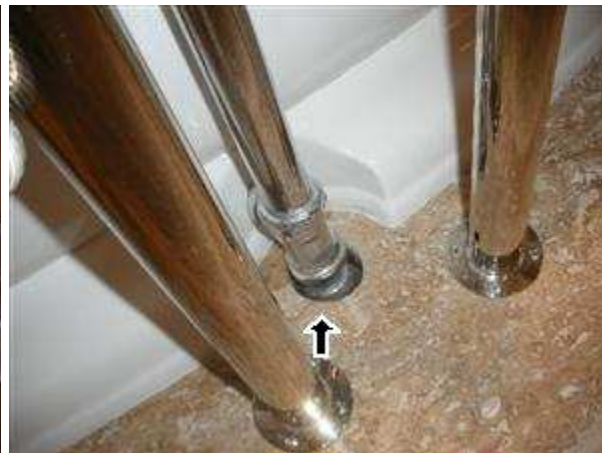
It should be noted that there were wall penetrations under sinks (Picture 1) and basins that have not been completely sealed against pest and / or cold air infiltration. There was also an opening around the floor penetrations of the drain pipe for the master bathroom bathtub (Picture 2) that should be sealed.

1) RR - Recommend that drain pipe wall penetrations under sinks and basins and the master bathroom tub be sealed with caulk or foam against cold air and pest infiltration.

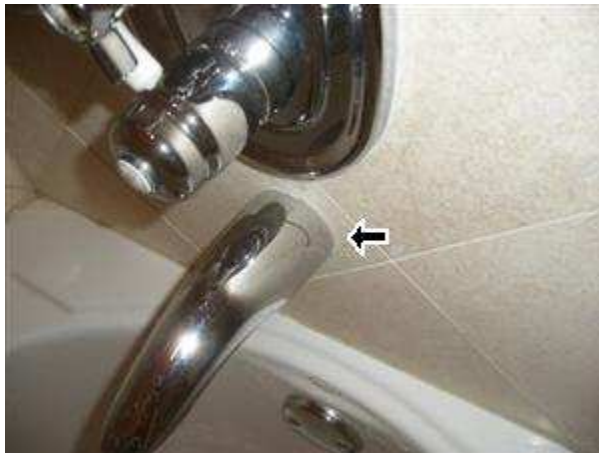
4.3 Picture 1

The bathtub spigot in the northeast bathroom (Picture 1) was not properly sealed to the tile wall.

1) RR - Recommend that the bathtub spigot in the X bathroom be properly sealed to the tile wall as a guard against water intrusion into the wall.

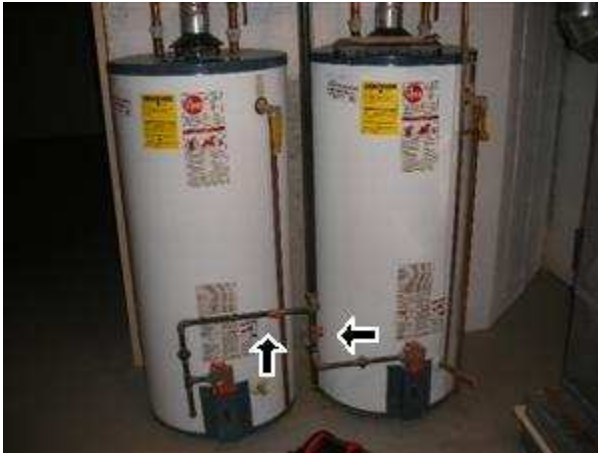
4.5 Picture 1

The water heaters was properly installed with di-electric fittings. It was observed through a heating cycle and displayed the proper colored flame. The TPR valve was properly vented to an approved pipe. The water heater vent flues was properly secured, sloped and secured to the vent flue and displayed no signs of backdrafting or carbon monoxide leakage. The water heater's gas shut-off

valve is indicated (Picture 1).

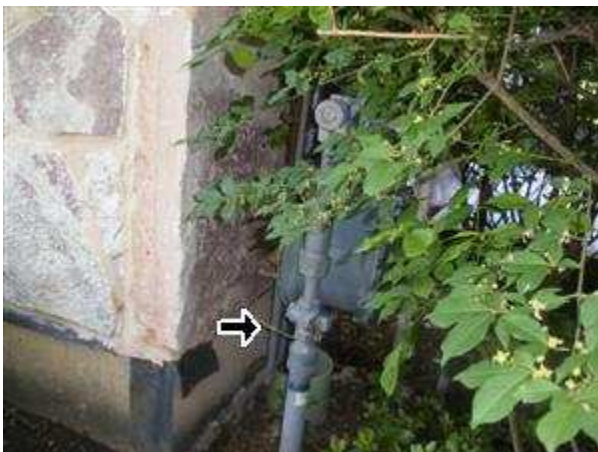
4.7 Picture 1

Main fuel (natural gas) shut-off was located on the utility meter (Picture 1) at the northwest corner of the house.

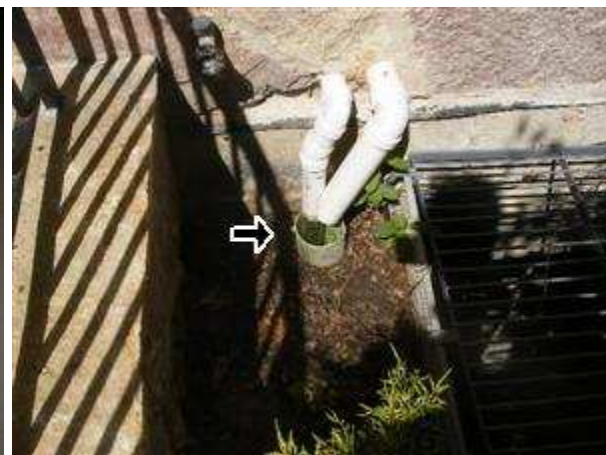
4.9 Picture 2

Where the sumps drained into underground piping (on the east side of the house, Picture 2) the sump pipes were oversplashing the ground pipe.

2) RR - Recommend that the sump pump pipes, where they drain into the underground piping, be equipped with an adaptor so as to avoid oversplashing.

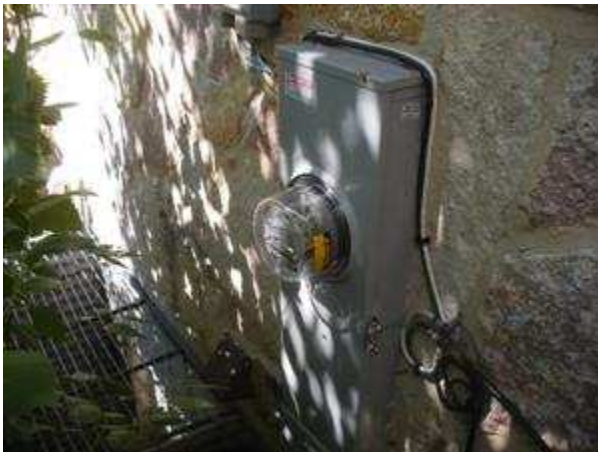
5.0 Picture 1

Electrical service is supplied by means of an underground (lateral) service drop from the utility pole to the meter box located on the east side of the house (Picture 1). The meter was rated for 200 amp service.

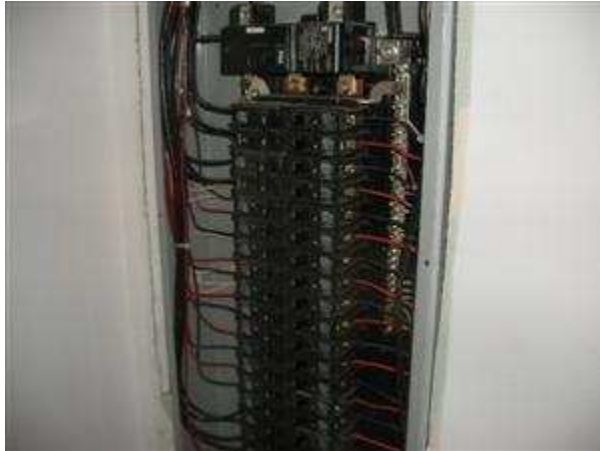
5.2 Picture 1

Wiring technique is neat and orderly (Picture 1). All raceways are properly bonded to the main service panel.

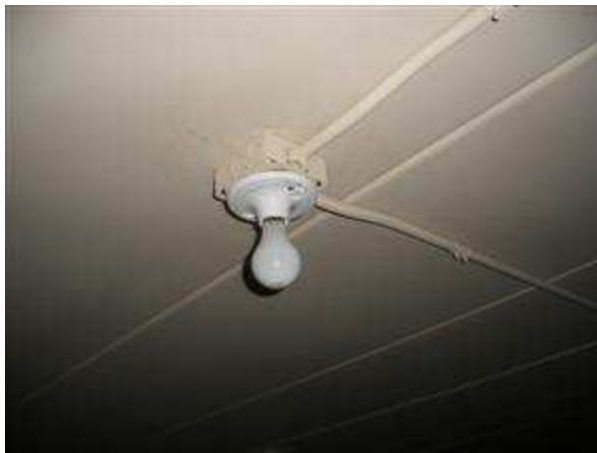
5.3 Picture 1

- Some basement and garage areas were lighted by bare bulb light fixtures (Picture 1). These type of fixtures are no longer approved for use because of the possibility of the bulb breaking and / or the bulb coming in contact with flammable material and starting a fire. These fixtures should be replaced with light fixtures that protect the bulb.
- There were exterior light fixtures that were not properly sealed to the exterior wall as a guard against water infiltration into the electrical system (Picture 2).

- 1) RR - Recommend that all exterior light fixtures be properly sealed to the wall to guard against water intrusion into the electrical system.
- 2) SD - Recommend that all bare bulb light fixtures be replaced with light fixtures that protect the

bulb from breakage and guard against fires. This is a safety hazard.

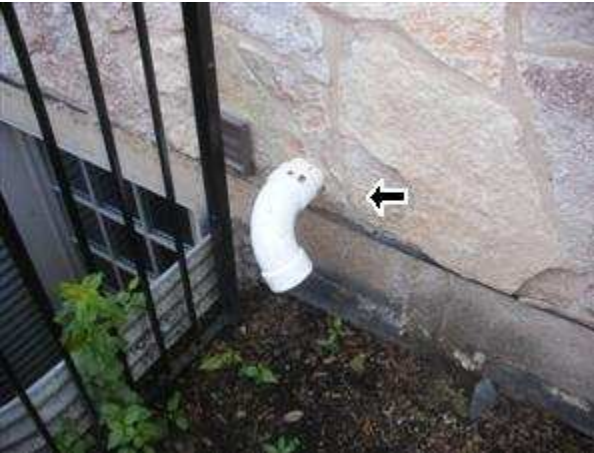
6.2 Picture 1

The furnaces was properly vented by means of PVC piping. The required combustion air intake vent was properly installed for the attic furnace. The basement furnace was vented out the west side of the house (Picture 1).

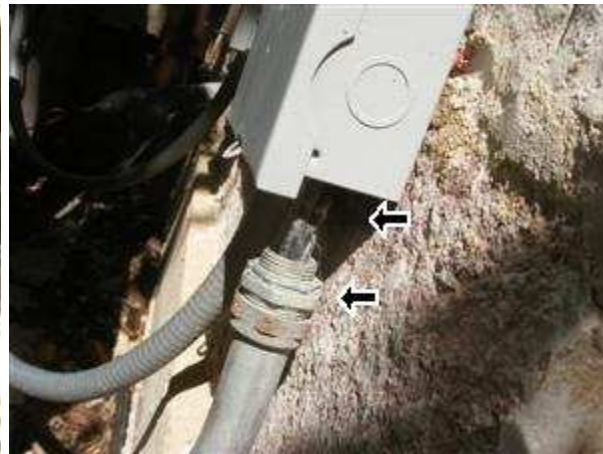
7.0 Picture 2

The power supply for one of the compressors was loose from the disconnect box (Picture 2).

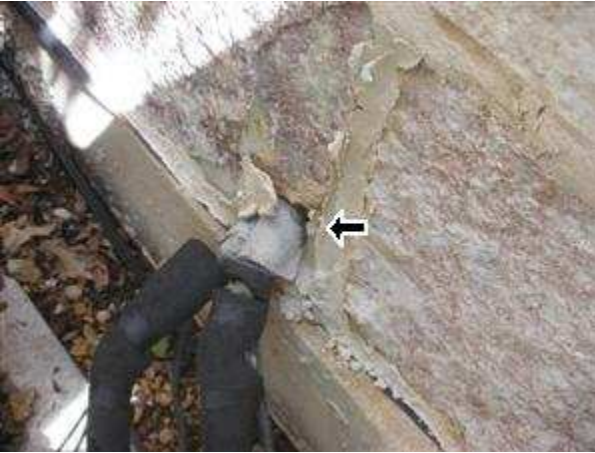
7.0 Picture 3

Where the A/C lines enter the house, the wall penetration is not properly sealed (Picture 3).

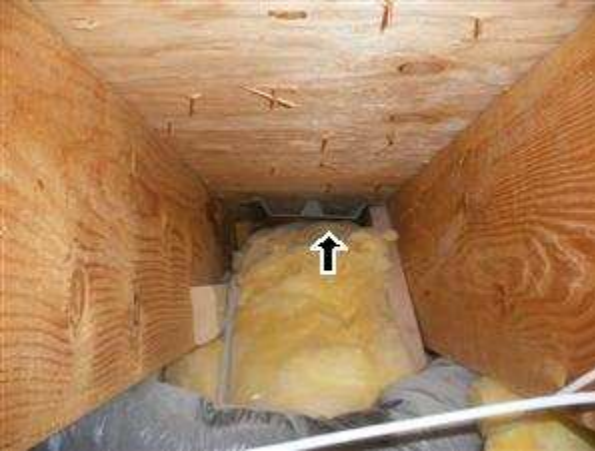
9.2 Picture 1

The attic is ventilated by a combination of soffit vents and ridge vents. The recommended baffles were in place over the soffit vents (Picture 1) to guard against insulation blocking the vents. Given the humid conditions present for several days prior to the inspection and the low moisture levels in the attic, the ventilation of the attic area appeared to be sufficient.
