WJD Decker
Home Services, LLC

Inspection Report

**Property Address:
1121 Small Street
Smallville, IL 60000**

Date: 10/2/2008	Time: 9:30 AM	Report ID: Sample Small
Property: 1121 Small Street Smallville, IL 60000	Customer: George Small	Real Estate Professional:

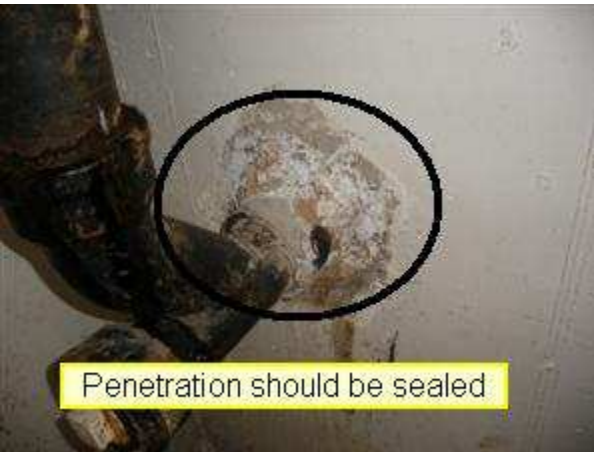
1.0 Picture 3

Foundation was poured concrete without exterior signs of cracking, efflorescence or water intrusion where observed. Interior inspection showed no signs of staining, water intrusion or efflorescence. There were a few minor cracks seen, radiating downward from the steel window pockets on the foundation wall, but these are not considered significant. There was one crack that was sealed with epoxy (Picture 1). The concrete slab displayed some minor cracking and signs of past water (efflorescence, Picture 2) but this was minor. The wall penetration for the main sewer pipe displayed some efflorescence (Picture 3) and should be sealed with epoxy.

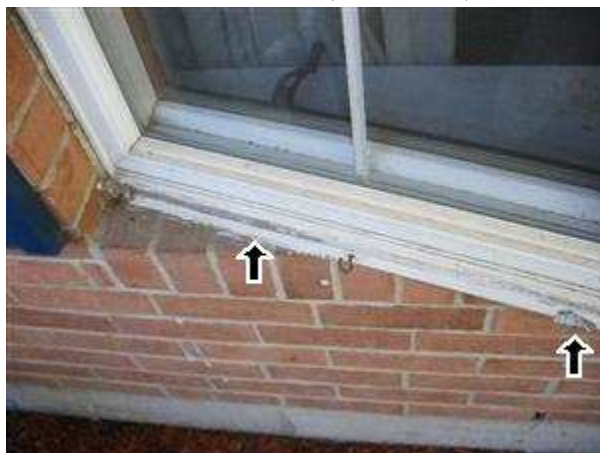
2.4 Picture 1

The exterior windows were wooden and displayed minor signs of peeling paint (Picture 1) and some caulk deterioration (Picture 2).

1) RR - Recommend that exterior window frames be scraped, primed and painted as a guard against further deterioration.

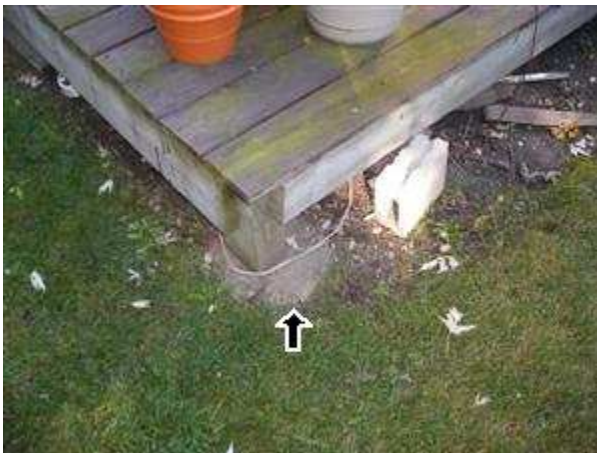
2.8 Picture 1

The rear of the house was equipped with a wooden deck which was properly footed (Picture 1) and displayed no signs of rot or unevenness. It was not equipped with railings or handrails, which are not required because the deck is not above 36". Given that there will be a small child in the house, it is recommended that railings be installed on the deck. The front porch was a concrete slab. It displayed no signs of cracking or displacement.

2) SD - Recommend that the rear deck be equipped with railings as a guard against harm to small children.

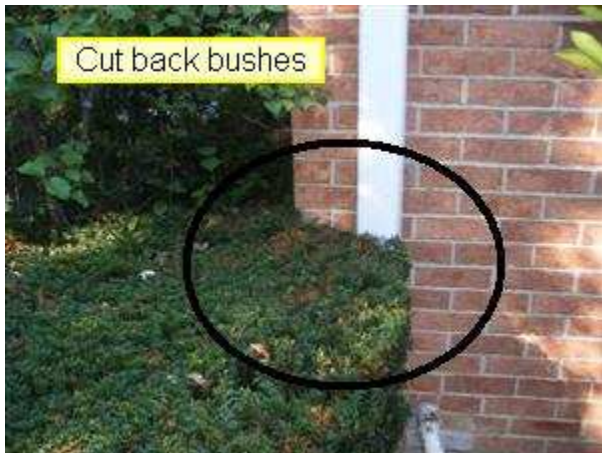
2.11 Picture 1

There was some vegetation growing against the house (Picture 1) and roof (Picture 2) that should be cut back.

2) WL - Recommend that the vegetation around the house's exterior be cut back and/or thinned out to allow for proper air flow and sunlight to properly dry the exterior of the house.

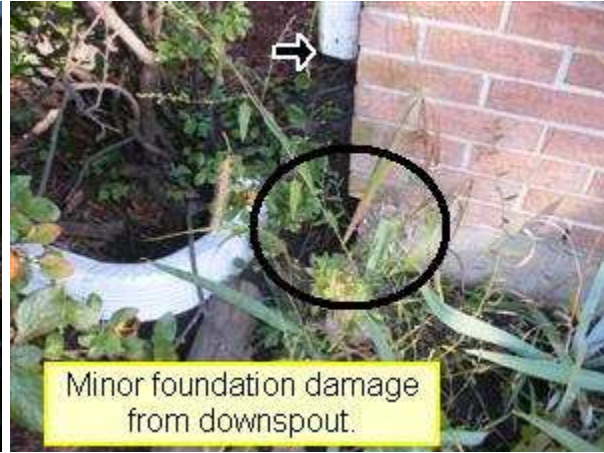
3.2 Picture 2

The downspouts displayed no signs of rust or physical damage and were properly secured to the house. There were some areas where the downspouts drained too close to the foundation of the house (Picture 2).

1) RR - Recommend that the downspouts be extended to release drainage water at least 6' away from the structure's foundation.

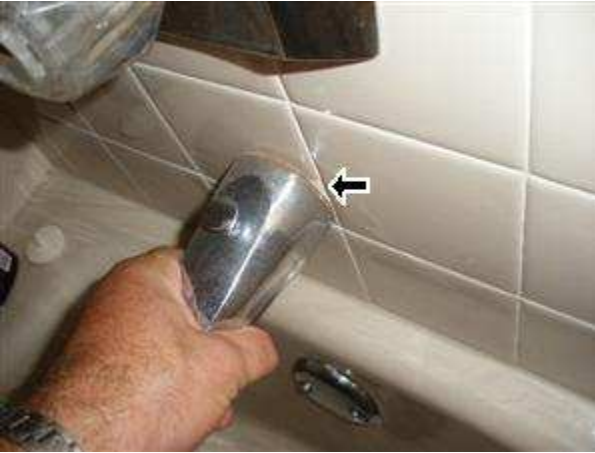
4.2 Picture 1

The bathtub spigot in the 2nd floor hallway bathroom (Picture 1) was not properly sealed to the tile wall.

- 1) WL - Recommend, as a preventative measure, that all basins, sinks and tubs be treated with a gel type drain cleaner every 2 months as a guard against drain blockage.
- 2) RR - Recommend that the bathtub spigot in the 2nd floor hallway bathroom be properly sealed to the tile wall as a guard against water intrusion into the wall.
- 3) RR - Recommend installation of an access panel to the whirlpool bathtub.

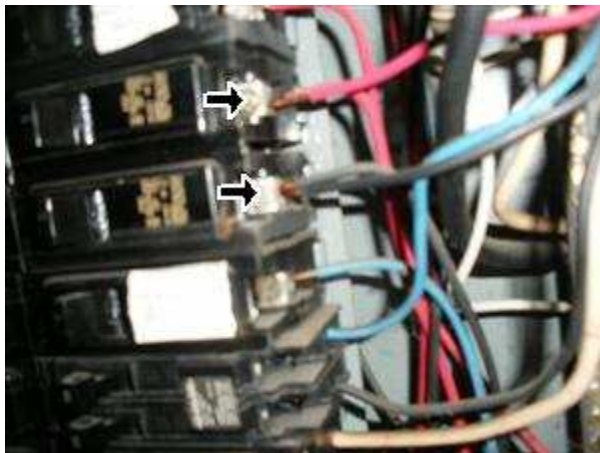
5.2 Picture 1

All overcurrent devices (circuit breakers) were of the proper type and were served by the correct gauge wire for their rated amperage. There were two double taps (Picture 1). All neutral conductors are properly seated in the neutral bus and the neutral bus is properly bonded to the panel and the ground.

1) RR - There were double tapped circuit breakers found in the electrical panel. This is when two or more branch circuit wires are attached to the same circuit breaker. Recommend this condition be evaluated and repaired by a licensed and insured electrical contractor.

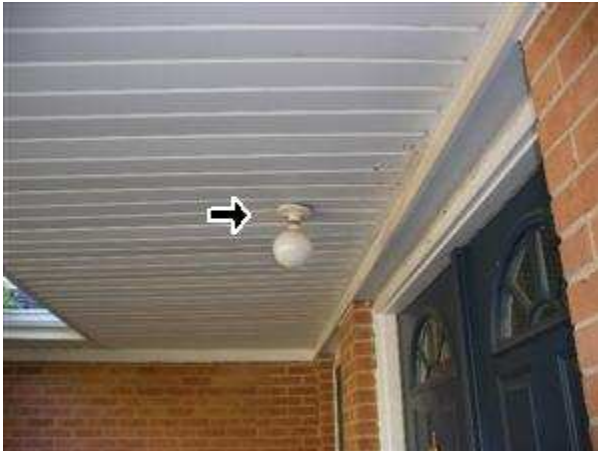
5.4 Picture 1

- Some basement and garage areas and the front porch were lighted by bare bulb light fixtures (Picture 1). These type of fixtures are no longer approved for use because of the possibility of the bulb breaking and / or the bulb coming in contact with flammable material and starting a fire. These fixtures should be replaced with light fixtures that protect the bulb.
- There were exterior light fixtures that were not properly sealed to the exterior wall as a guard against water infiltration into the electrical system (Picture 2).

1) SD - Recommend that all bare bulb light fixtures be replaced with light fixtures that protect the bulb from breakage and guard against fires. This is a safety hazard.2) RR - Recommend that all exterior light fixtures be properly sealed to the wall to guard against water intrusion into the electrical system.

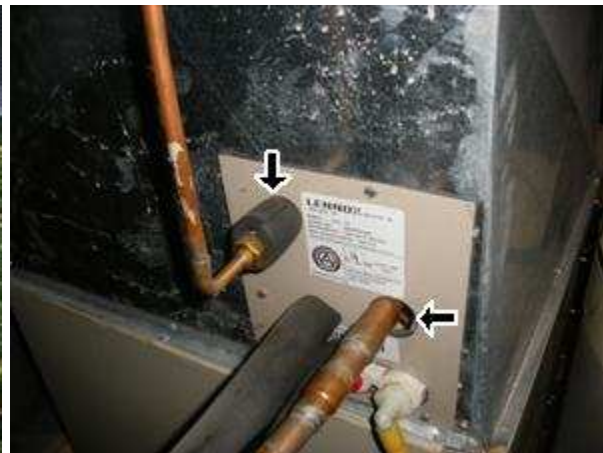
7.0 Picture 2

The lines to the plenum coil were not properly sealed to the plenum above the furnace (Picture 2). When operated, the A/C system displayed signs of refrigerant loss.

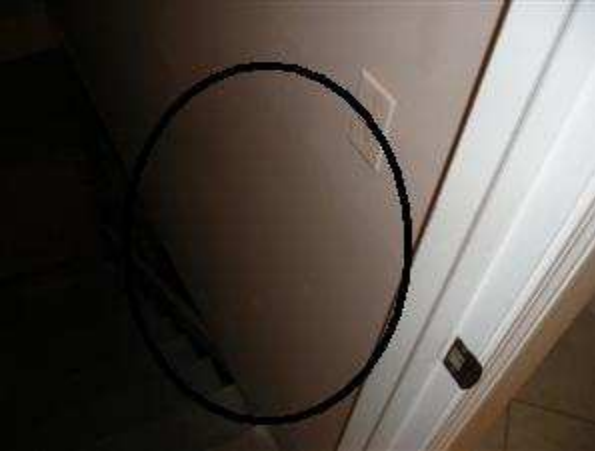
8.5 Picture 1

Upper level and basement stairs were even, tight and secure. The stairway to the basement was not properly equipped with handrails (Picture 1).

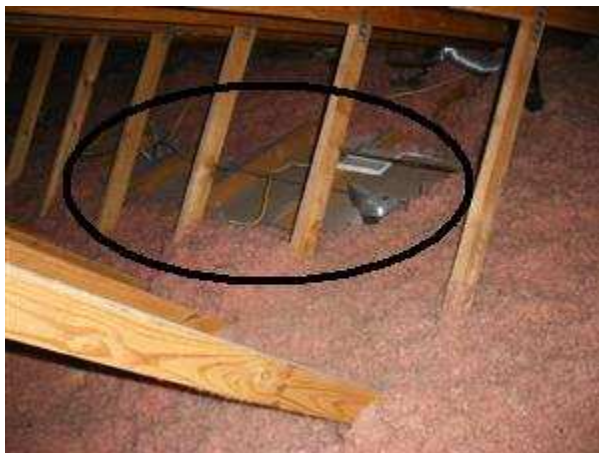
9.0 Picture 1

There were areas where the existing insullation was removed (Picture 1) and should be replaced.

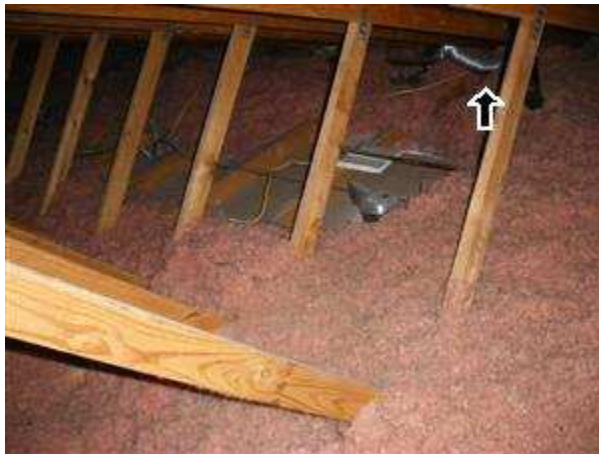
9.2 Picture 1

Bathroom were equipped with ceiling exhaust fans which was not properly vented to the exterior (Picture 1).

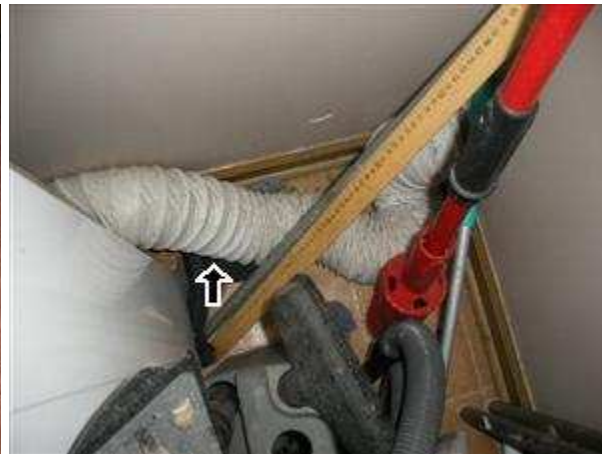
9.2 Picture 2

It should be noted that the clothes dryer vent (Picture 2) was vented by means of a vinyl vent hose. There have been many reports of fires caused by the use of vinyl vent hoses due to their flammable characteristics.

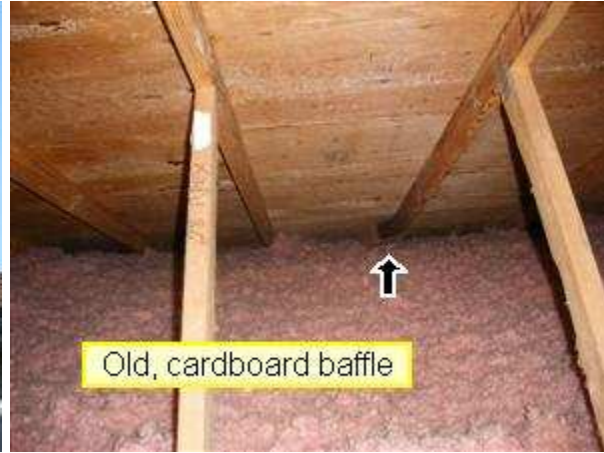
9.4 Picture 2

The attic is ventilated by a combination of soffit vents and roof vents with a power vent fan (Picture 1). The recommended baffles were not all in place (Picture 2) over the soffit vents to guard against insulation blocking the vents. There was also a power vent fan, which did not operate.

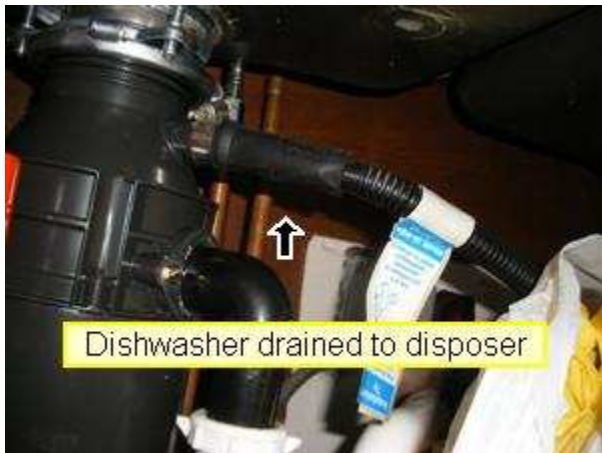
10.0 Picture 1

2) RR - The dishwasher in the kitchen was drained into the disposer (Picture 1) and not the drain pipe, which is not allowed. Recommend that the dishwasher drain hose be connected to the sink drain pipe as required.

1) SD - Recommend that the dishwasher drain be re-installed so as to provide for a high loop, where the dishwasher drain pipe is secured to the underside of the base cabinet countertop and 'looped' so that the loop is at the "flood level" of the sink drain. This will guard against water back flowing from the drain into the dishwasher and guard against contamination of the dishes with drain waste water.
