Inspection Report

**Property Address:
222 Lost Energy Lane
Big House Town, IL**

Date: 1/13/2010	Time: 10:30 AM	Report ID: Sample Energy Audit
Property: 222 Lost Energy Lane Big House Town, IL	Customer: Mary Nonefficient	Real Estate Professional:

The subject property is a Victorian type style house originally built in 2007. The client requested an inspection with regards to energy loss, air infiltration and energy efficiency.

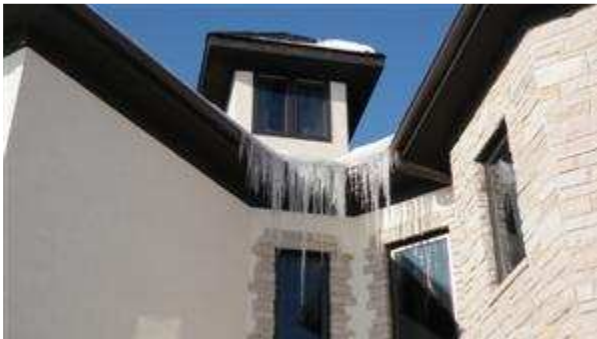
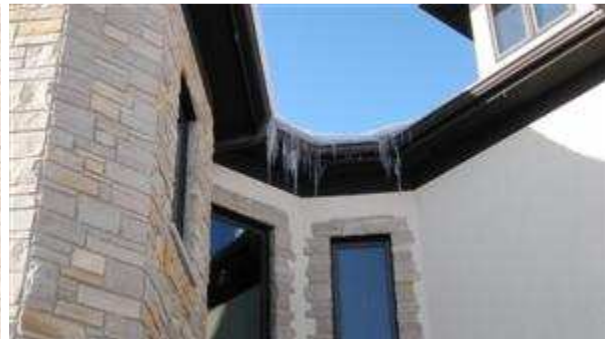
There were multiple areas that exhibited excessive icicle formation, at the front (Picture 1, 2) and rear above the master bedroom balcony area (Picture 3). These areas coincide with the attic knee wall areas and the balcony area coincides with the placement of one of the attic furnaces. The heat loss in these areas, through the roof, is causing these icicles and ice damming (Picture 4), which will, over the long term, greatly shorten the life of the roof.

1) RR - Recommend that the knee wall areas, under the roof, be insulated with a spray foam type insulation installed on the underside of the roof and that the soffit vents be sealed in these areas.

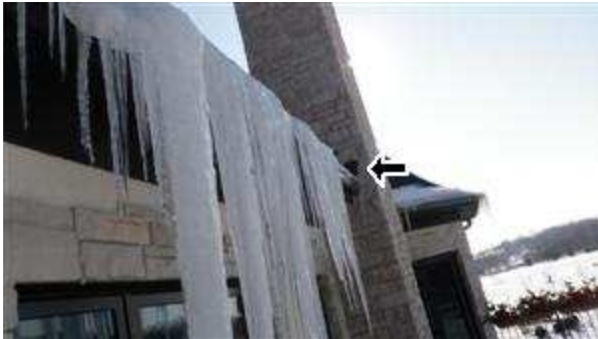
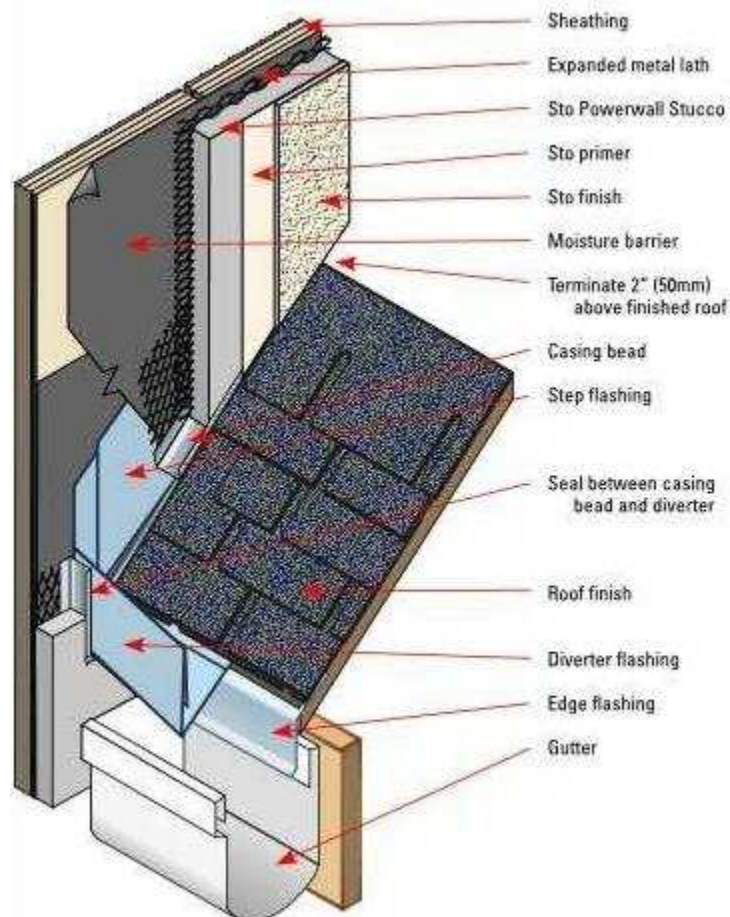
The rear roof area, over the master bedroom balcony and adjacent to the rear chimney, is not equipped with the required kick-out flashings (Picture 1, 2). This is, at least, one of the causes of the water leakage seen around the chimney area.

1) RR - Recommend that the required kick-out flashings be installed where the roof planes end against side walls as a guard against water intrusion into the walls at these areas.

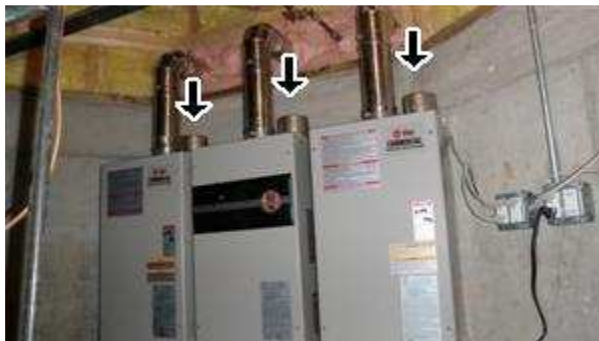
2.0 Picture 1

The house was equipped with 3 tankless, high efficiency direct vent water heaters, manufactured in 2008 and located in the utility room in the basement. The units operated properly. However they were not installed per the manufacturer's installation instructions. Direct vent water heaters require a combustion air vent flue so that combustion air is taken from the outside of the house. This condition has greatly lowered the energy efficiency of these water heaters and will also shorten their life. It also contributes to the house's negative indoor pressure condition.

1) RR - Recommend that the water heaters be evaluated and their installation repaired by a state licensed and insured plumber with HVAC experience and factory trained and certified by the water heater's manufacturer.

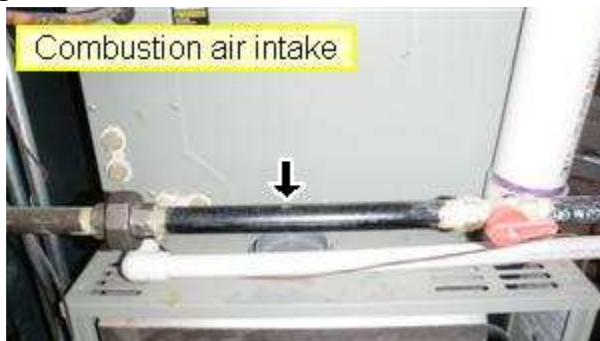
3.0 Picture 1

The house was heated by three category 4 high efficiency induced draft furnaces, two in the upper area of the house and one in the basement. The basement furnace did not have the manufacturer required combustion air intake vents (Picture 1). This causes the furnace to draw combustion air from the house;'s interior air. This condition has lowered the efficiency of the furnace (by about 10%) and will reduce the furnaces life. It also causes the house to be under negative interior air pressure, which further enhances the cold air infiltration problem.

2) RR - Recommend that the category 4 high efficiency furnace be provided with a combustion air vent, as required by the manufacturer. Recommend that the installation of this vent be done by a licensed and insured HVAC contractor.

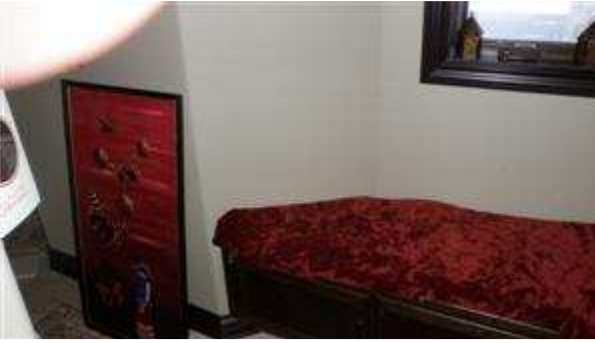
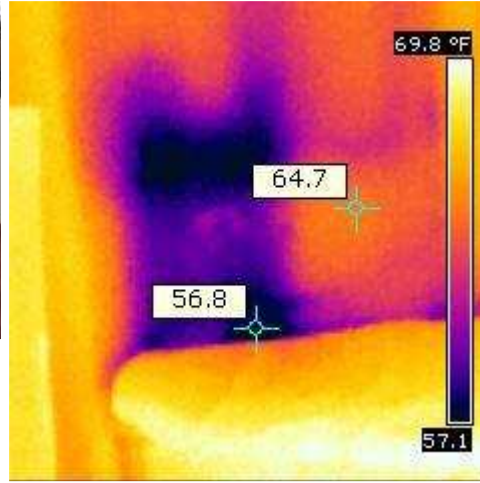
The built-in seat area, at the front of the house, displayed signs of cold air infiltration and lacking insulation behind the built-in seat (Picture 1, 2) with an eight degree difference.

If an upgrade is done, recommend that a non-organic foam type insulation be used so as to properly seal the insulation and reduce the effects of air and moisture changes on the R value of the insulation.

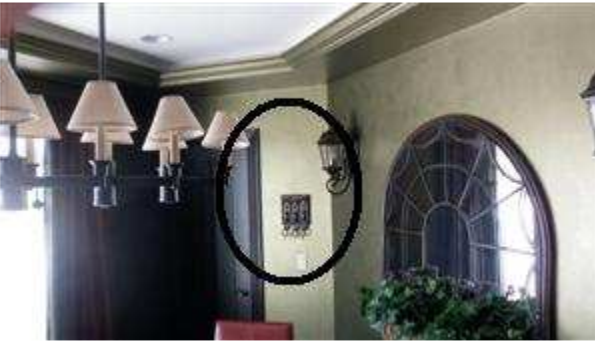
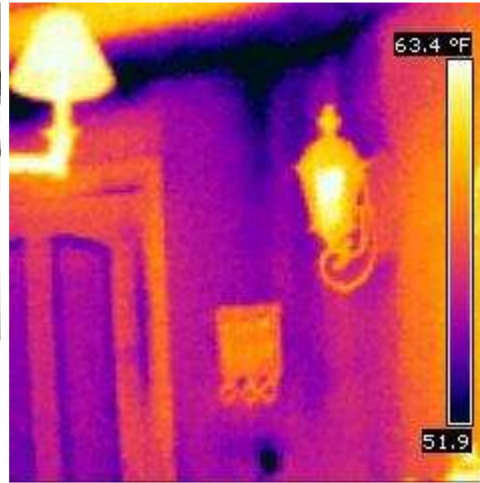
The corner closet, at the rear of the house and adjacent to the garage, displayed an almost complete lack of insulation (Picture 3, 4) . This condition also exists in the area of the 2nd floor, above.

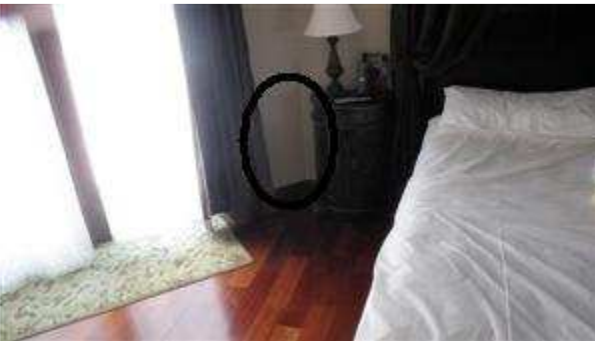
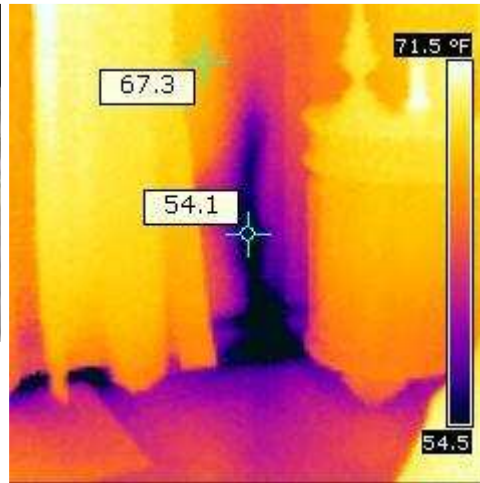
The small area adjacent to the balcony window in the master bedroom displayed an area of cold air infiltration from the rim joist area (Picture 5, 6).

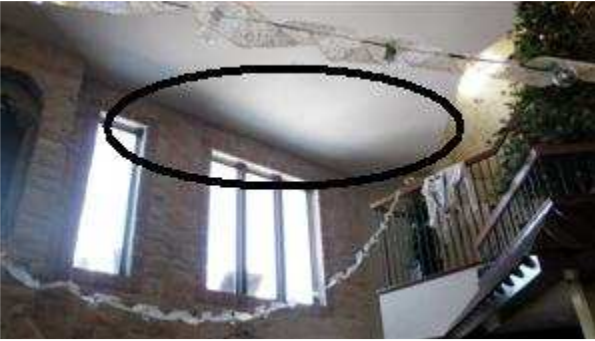
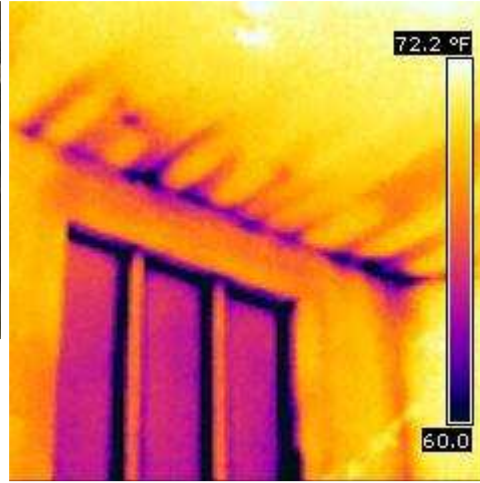
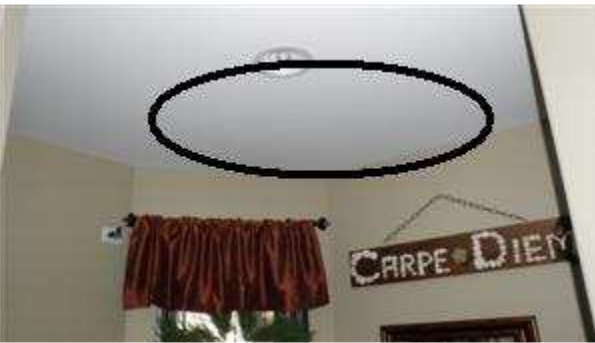
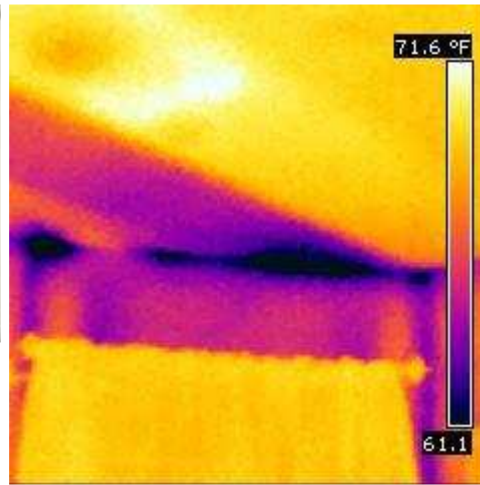
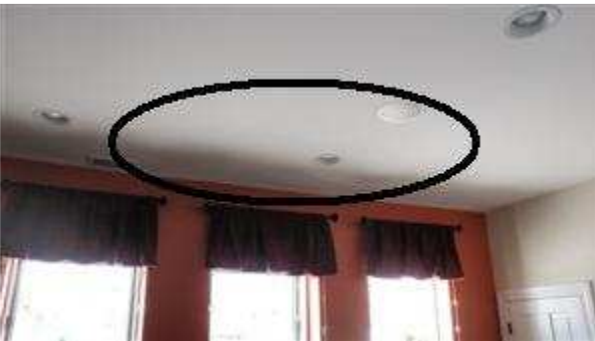
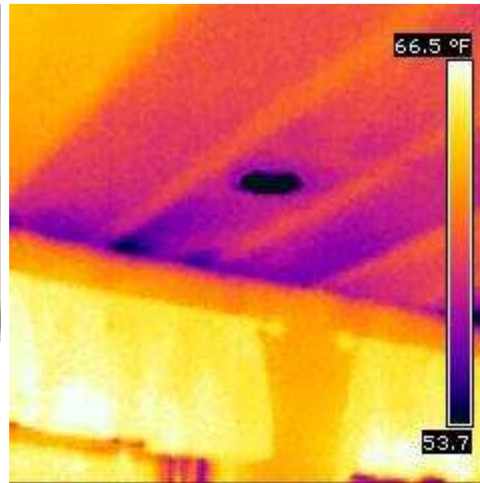
This cold air infiltration problem is clearly seen from the main room of the house, looking up at the ceiling (Picture 7, 8) and in small areas where the cold air is traveling between the ceiling / floor joists (Picture 9, 10) and in the rear room (Picture 11, 12) as well as from the exterior floor areas.

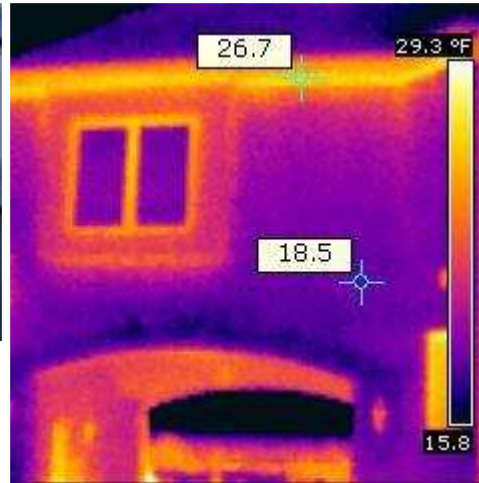
4.0 Picture 14

Exterior imaging displayed areas around window built-outs and at the roof's soffit area, where there is lower insulation and heat loss (Picture 14).

Current best practices call for the underside of the roof to be insulated and ridge and soffit vents to be sealed.

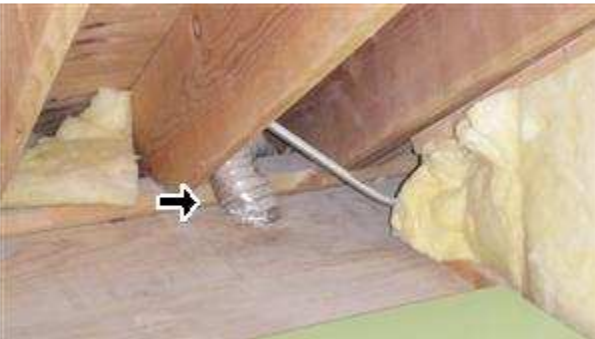
4.2 Picture 1

There were various areas where the bathroom exhaust vents are being vented to the roof's soffit area (Picture 1). This will allow for moist air to be drawn up into the attic area and cause rot and organic growth.

1) RR - Recommend that bathroom exhaust fans be vented through roof jack vents and not through soffit vents as required by current national standards.
