**WJD Decker**  
**Home Services, LLC**

## **Inspection Report**

**Condo Association**

**Property Address:  
2222 W. Water St.  
Swamptown, IL**

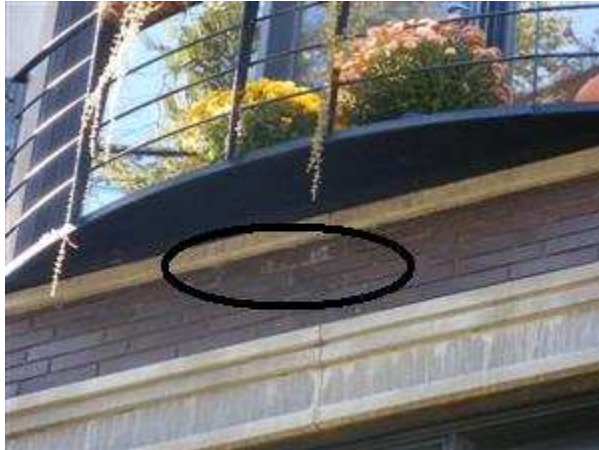
1.0 Picture 1

The exterior of the house was covered with finished brick and stone (front) and split faced block (sides and rear). The brick displayed areas of efflorescence ( Picture 1 ) mortar loss ( Picture 2 ) as well as non-professional installation ( Picture 3, misaligned inside corner ) and improper mortaring technique ( Picture 4 ).

1) RR - Recommend that the entire exterior wall coverings of the building be evaluated and repaired by a licensed and insured masonry contractor.

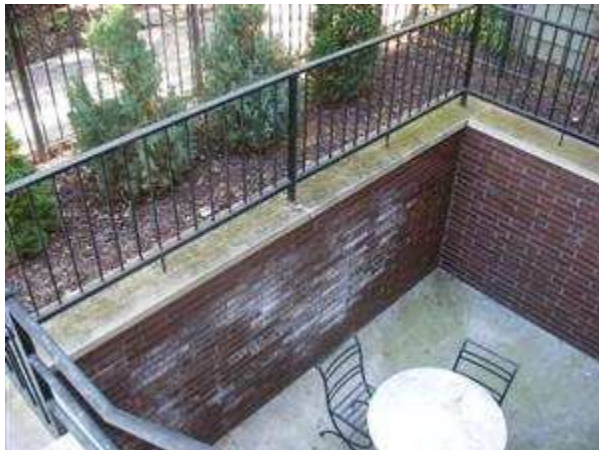
1.0 Picture 5

The front patio area coping tiles were not flashed and have allowed water to enter the brick, below, causing significant efflorescence ( Picture 5 ).

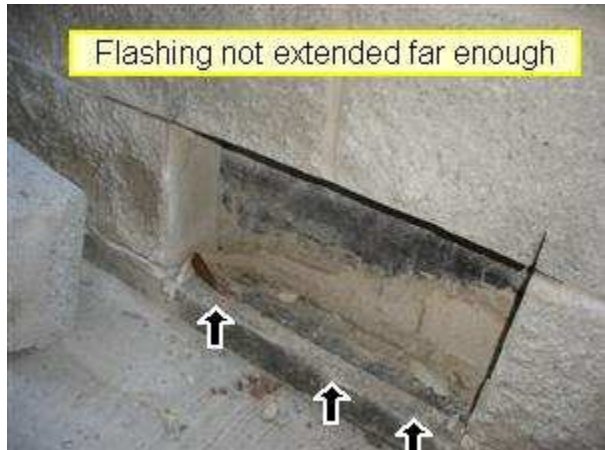
1.0 Picture 6

The split block on the back and sides was not properly flashed. It had weep wicks missing and the flashing at the foundation level was not properly extended out from the wall ( Picture 6 ). It is assumed that the flashing at the upper levels was similarly installed. The wall displayed some retained moisture at upper level flash courses ( Picture 7, 8 ) with some moisture leakage past the flash courses.

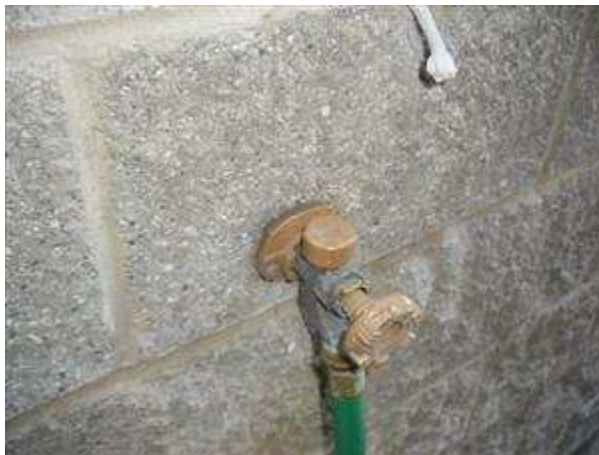
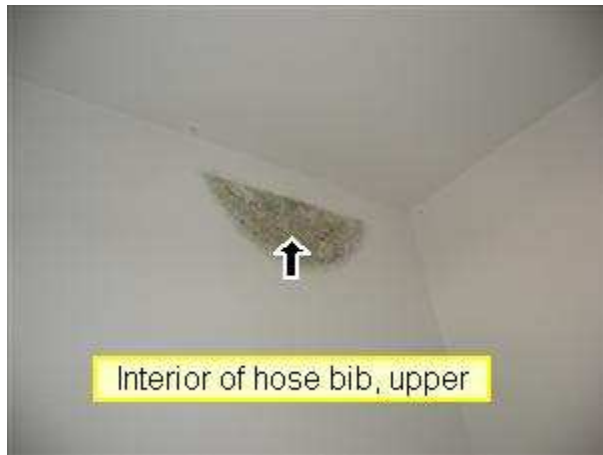
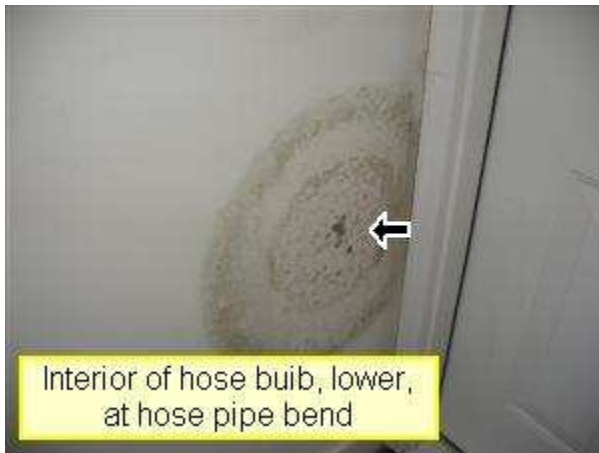
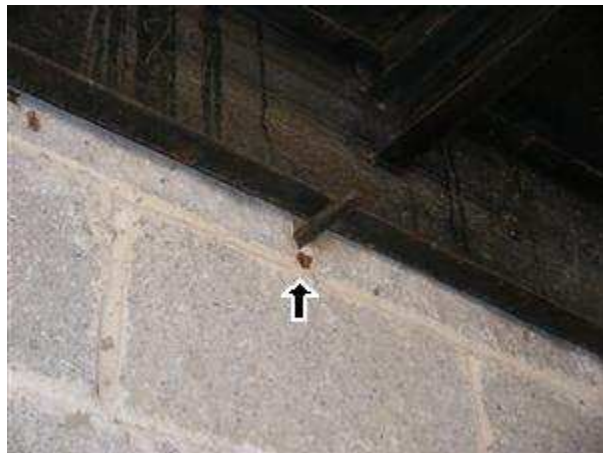
There were multiple areas where the exterior wall penetrations were not properly sealed. The hose bib was not properly sealed ( Picture 9 ) which has allowed water to enter and cause mold formation on the north wall of the rear basement area ( Picture 10, 11). The unsealed rear balcony stakes ( Picture 12 ) and the unsealed electrical and HVAC flues

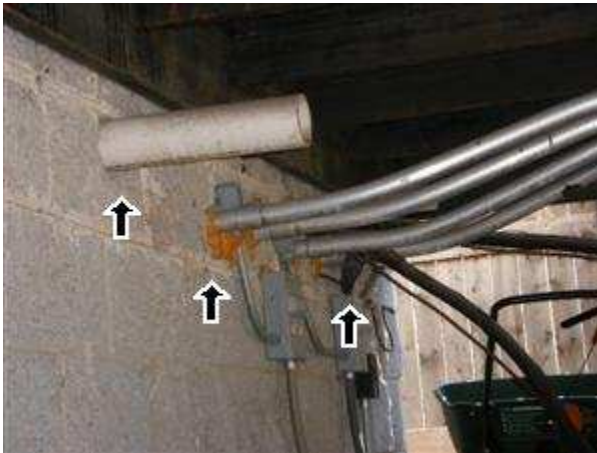
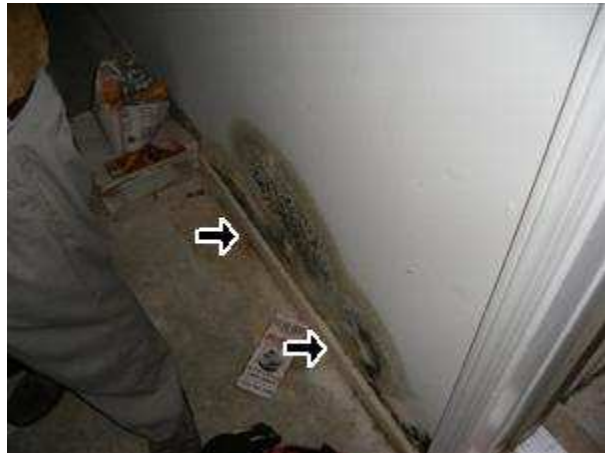
( Picture 13 ) have allowed water to enter and cause mold formation on the rear basement wall ( Picture 14 ). The unflashed rear porch ledger boards ( Picture 15 ) have allowed water intrusion and mold growth at the top and side of the rear basement door ( Picture 16 ) and a split downspout had allowed excessive moisture on the south rear basement area ( Picture 17 ) has caused mold growth on the interior of this area ( Picture 18, 19 ).

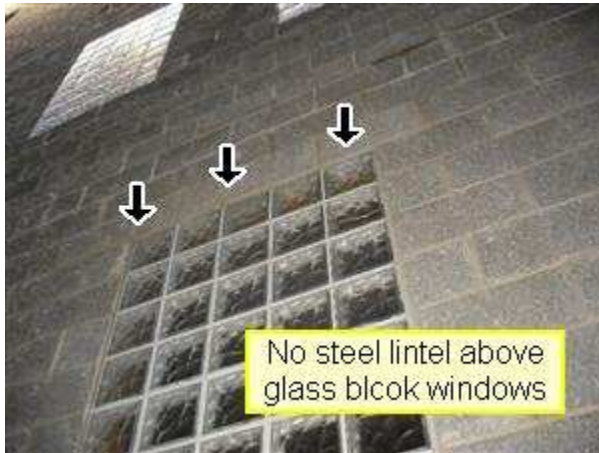
1.2 Picture 1

The building was equipped with multiple glass block windows. The use of such windows and their installation without the upper masonry being supported by steel lintels ( Picture 1 ) is not a recommended construction technique.

1) RR - Recommend that steel lintels be installed above the glass block windows. As an upgrade, it is recommended that the glass block windows be replaced with more energy efficient windows.

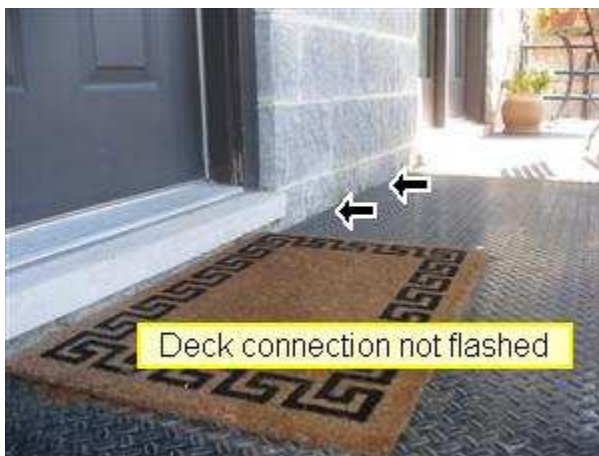
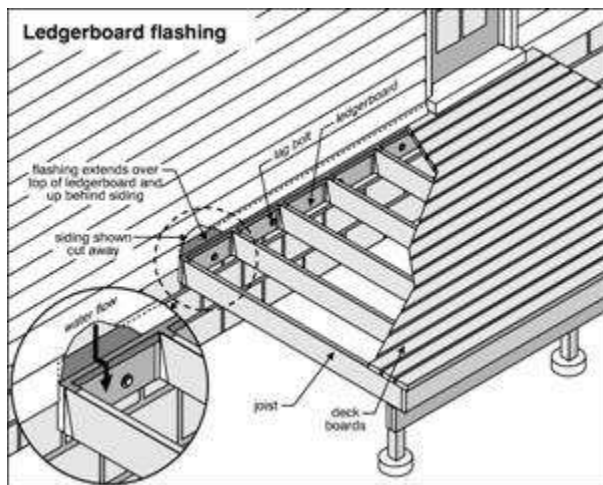
The rear of the building was equipped with metal decks, secured to the building with the required metal rods. Where the deck's ledger boards were attached to the building, there was no flashing ( Picture 1 ). Proper installation of a deck or porch ledger board to a building requires metal flashing above the ledger to divert water running down the exterior wall away from the ledger board and the wall penetrations that holds the ledger board ( Picture 2 ).

1) RR - Recommend that the ledger boards for the rear decks / porches be equipped with the required flashing above their ledger boards and that the flashing be counter flashed into the mortar joints and that the work be done by licensed and insured masonry contractors.

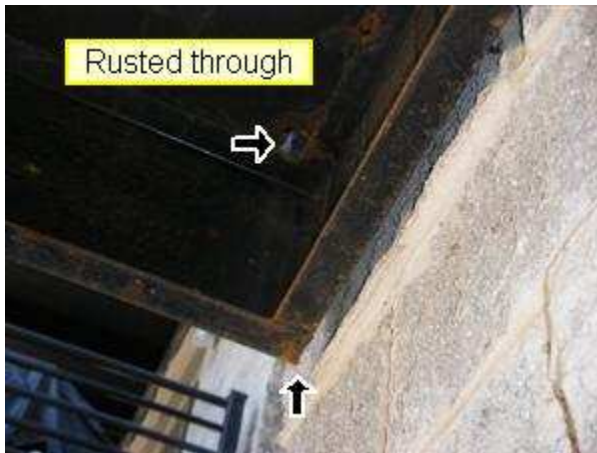
1.4 Picture 3

This problem is evidenced by the water infiltration into the rear basement area (see section 1.0) and the rust seen on the underside of the deck ( Picture 3 ).

2) RR - Recommend that the rear metal decks / porches be scraped, primed and painted by a licensed and insured painter who specializes in metal exterior painting.

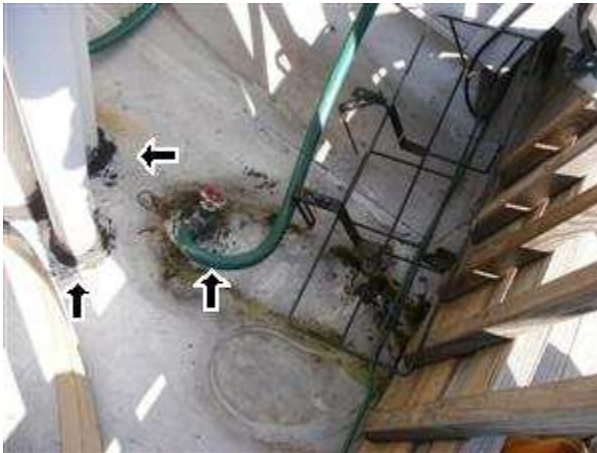
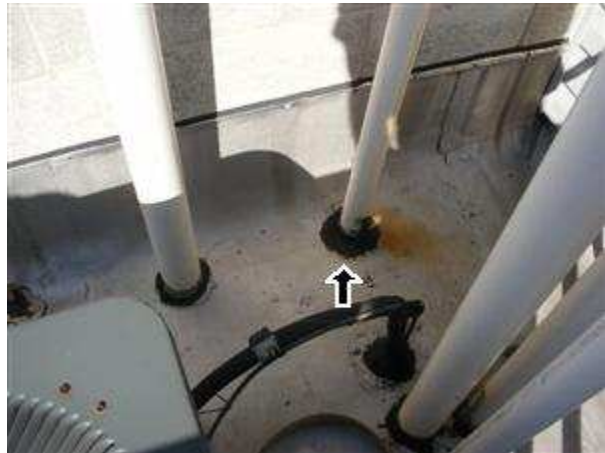
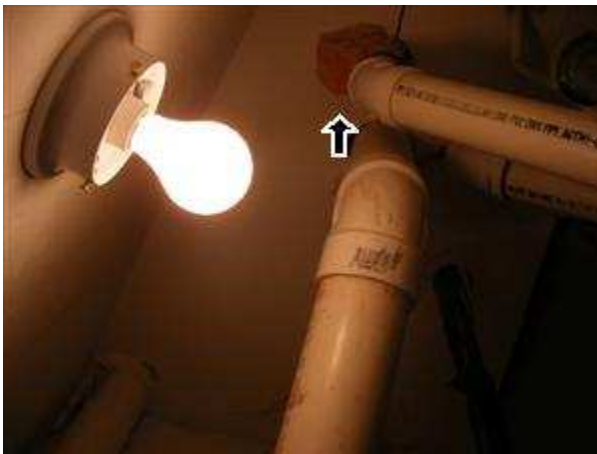
The roof had multiple roof penetrations, none of which were properly of professionally flashed ( Picture 1 ). There was water leakage through these flashings into the utility closet of the 3rd floor unit ( Picture 2, 3 ).

1) RR - Recommend that, as part of a roof repair, that the roof penetrations be properly and professionally sealed. Recommend that the work be done by a state licensed and insured roofer in accordance with best practices.

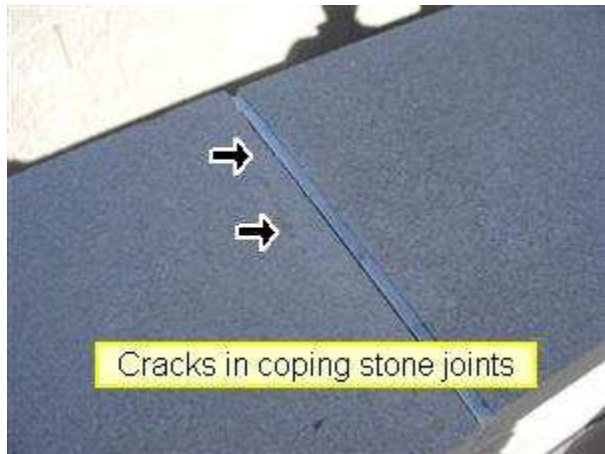
2.2 Picture 4

The coping stone on the top of the roof's parapet wall was not properly sealed at its joints ( Picture 4 ) and there was no evidence of flashing under the stone. Both these conditions will allow water to enter the exterior walls.

2) RR - Recommend that the coping stones on the parapet wall be properly flashed by a licensed and insured masonry contractor.

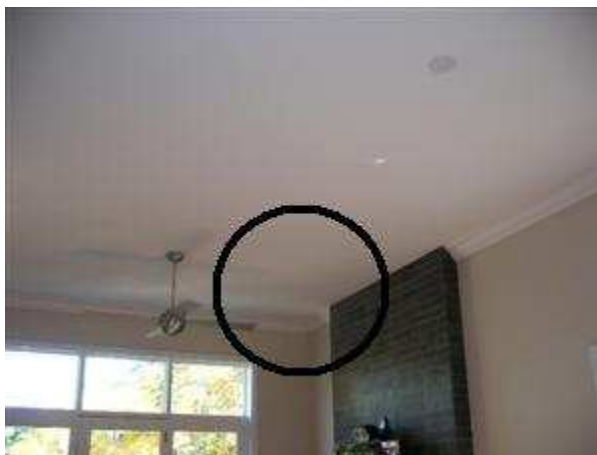
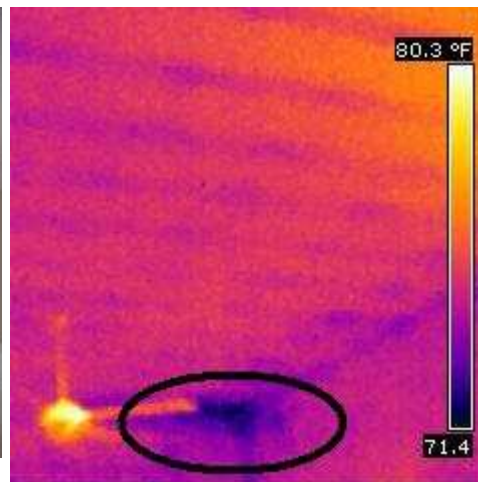
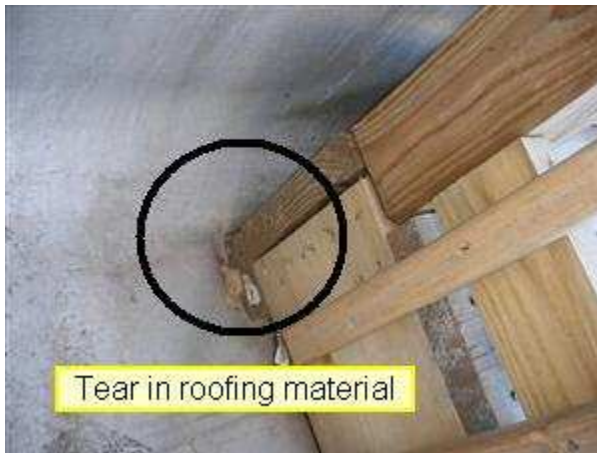
The southeast corner of the 3rd floor unit displays signs of moisture intrusion ( Picture 1, 2 ) which is, most probably, caused by damage to the roof ( Picture 3 ) from the improperly installed roof deck. Modified bitumen roofs are not to be covered with roof decks.

There is some ceiling involvement with the moisture entering the north wall, but most of the ceiling mold is caused by other exterior wall penetrations that were not properly sealed. The southeast corner of the 3rd floor unit has water intrusion from the roof deck. Roof decks are not supposed to be installed on modified bitumen roofs because they tear the roof covering.

- 1) RR - Recommend that the water damaged ceilings be replaced after the moisture intrusion is stopped.
- 2) RR - Recommend that the roof deck be removed and the roof patched.

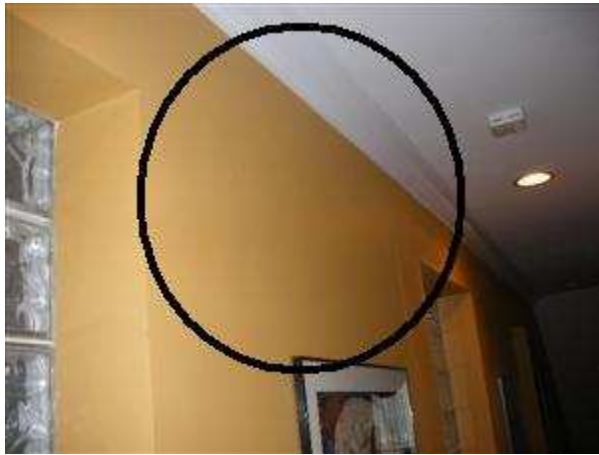
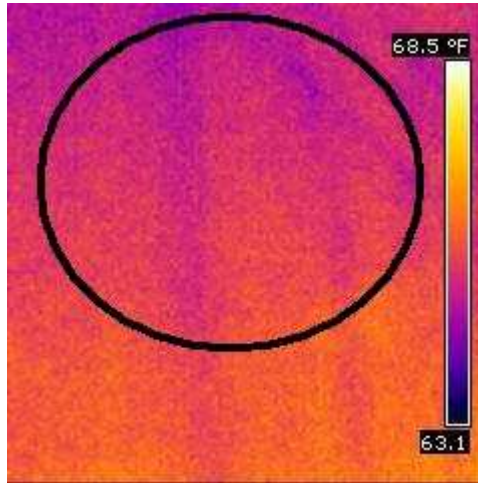
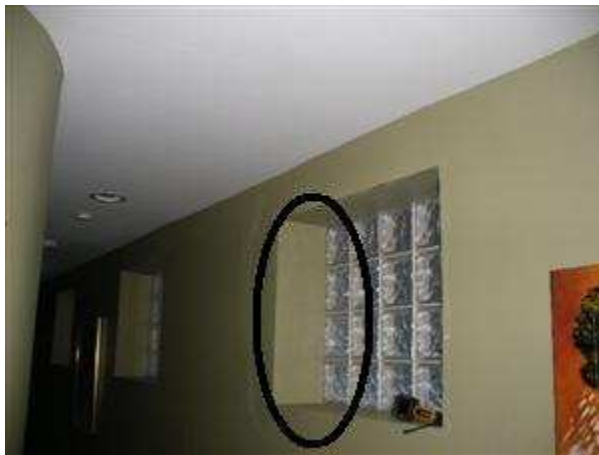
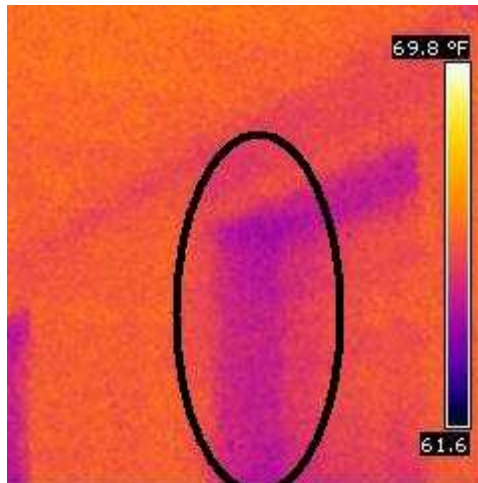
The walls in the rear basement area, under the stairs in the front finished basement and the entire north wall of the building displayed signs of increased moisture content. This was seen in the upper stories (above grade level) as generalized increased moisture content with significant wooden stud saturation (16 to 23% WE) while the north wall of the lower level revealed higher moisture levels on the wall ( Picture 1, 2 ) and around the glass block window wells ( Picture 3, 4 ) with moisture readings between 19 and 32% WE.

3.2 Picture 1 Basement, North wall

3.2 Picture 2 Basement, North wall, thermal

3.2 Picture 3 Basement, North wall

3.2 Picture 4 Basement, North wall, thermal

The north walls of the building are moist, with most of the moisture concentrated in the rear basement and north wall of lower level finished area. The moisture in the upper floors is less and more diffuse, with only isolated, closed areas (such as closets and utility

1) RR - Recommend that the walls be evaluated by a certified mold remediation company.

3) RR Recommend that the walls on the rear lower level area be completely removed and remediated by a certified mold remediation company. Recommend clearance testing after the work is complete.

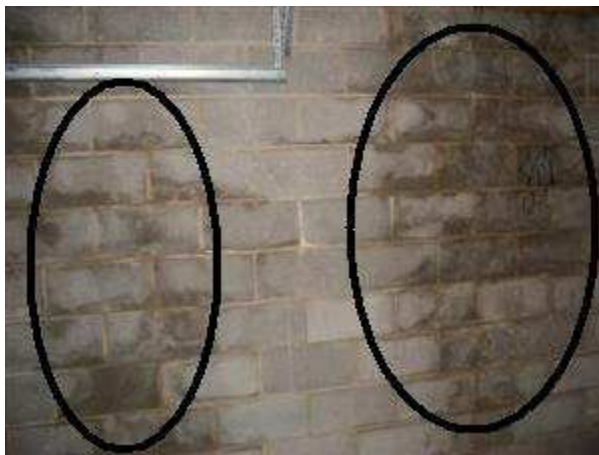
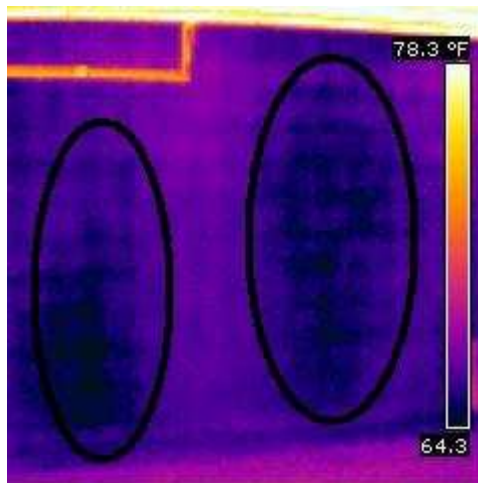
The north wall of the garage, where it is in contact with the adjacent garage wall displayed significant moisture intrusion ( Picture 5, 6 ). This is, most likely, caused by the exterior garage door being in contact with the adjacent garage.

3.2 Picture 5 Garage, North wall.

3.2 Picture 6 Garage, North wall, thermal

2) RR - Recommend that the north garage wall be evaluated and repaired by a licensed and insured masonry contractor.

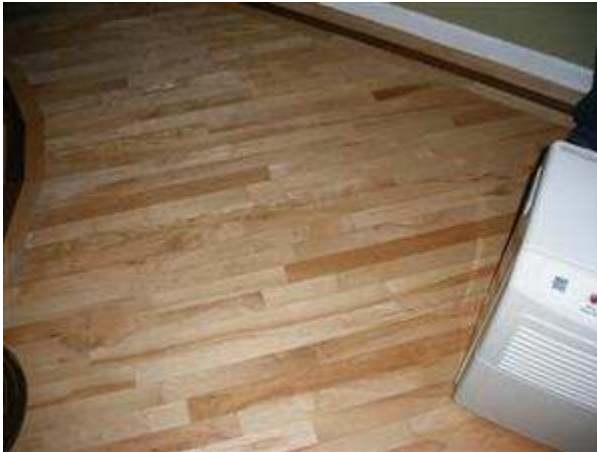
3.4 Picture 1

The lower level floors of the 1st unit were hardwood tongue and groove. They displayed signs of buckling ( Picture 1 ) and water damage, especially along the north wall and in the hallway area. This is caused by a combination of the water intrusion and that the floors were installed directly on the concrete slab floor, which is not an approved installation.

1) RR - Recommend that the hardwood floors in the lower level be removed and replaced once the floor level has been raised. The use of a floor raising product, such as Dricore, is highly recommended.
