WJD Decker
Home Services, LLC

Inspection Report

**Property Address:
1234 5th St
Anytown, IL**

| Date: 6/10/2008 | Time: 10:30 AM | Report ID: Sample Large |

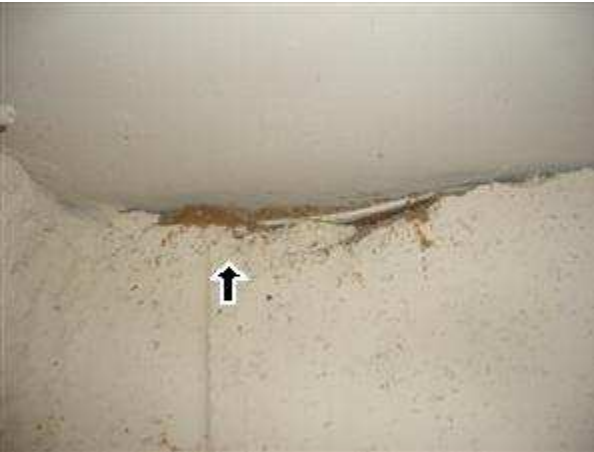
1.0 Picture 3

It should be noted that there was evidence of carpenter ant activity at the garage door lower corner areas (Picture 2) and at the corresponding area in the basement under the garage (Picture 3). Carpenter ants do not "eat" wood, like termites do, but merely burrow into the wood to live there. These insects can be easily dealt with by doing bi-annual perimeter spraying.

2) RR - Recommend evaluation of carpenter ants by a licensed and insured pest contractor.

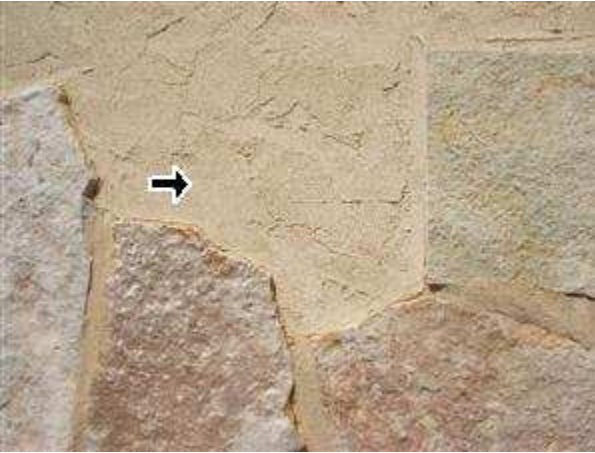
2.0 Picture 1

The exterior walls of the house were covered with a combination of stone veneer and stucco. The stucco displayed no signs of surface cracking but there were a few small areas (located at a few of the stone / stucco interface areas, Picture 1) where the stucco was slightly separated from the underlying substrate. There were also some stucco / stone interface areas that displayed minor cracking (Picture 2). Thermal imaging and deep probing moisture meter readings were within normal limits and there were no signs of moisture intrusion behind the stucco.

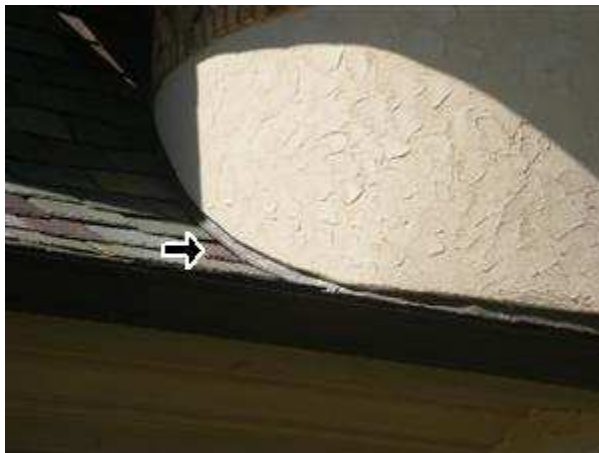
3.1 Picture 1

All roof penetrations were inspected and displayed proper flashing. The chimney was equipped with step and counter flashing which was intact. The flashing of the roof to the stucco sidewalls (Picture 1) was metal and the stucco was properly installed so as not to contact the roof.

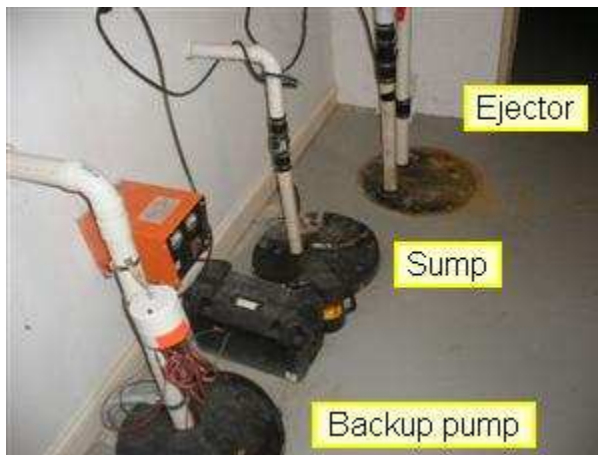
4.9 Picture 1

The house was equipped with two sump pumps (one being a battery powered emergency pump) and an ejector pump. Both were operating properly at the time of the inspection. Neither was equipped with a 120 volt battery backup.

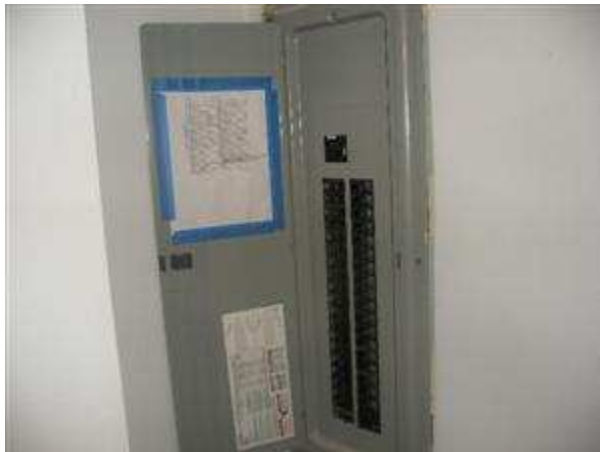
5.1 Picture 1

All raceways are metal conduit and are properly secured and bonded. The grounding conductor and the neutral conductor are properly floated and the ground conductor was properly bonded to the panel.

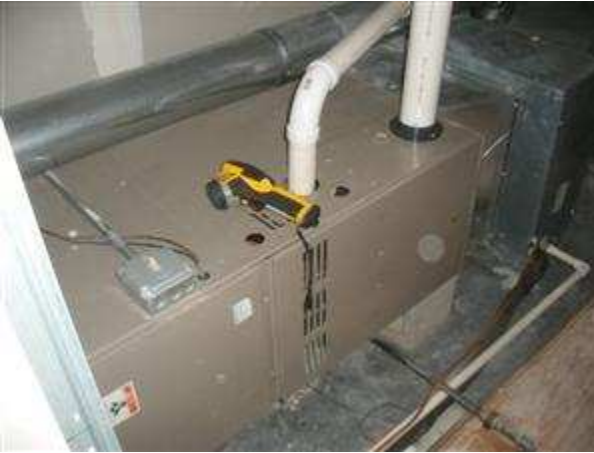
6.0 Picture 1

Heating was provided by means to two furnaces, one located in the basement and one located in the attic area. Both furnaces were Goodman high-efficiency units manufactured in 2002. The attic furnace (Picture 1) was properly installed so as to draw their combustion air from the exterior of the house while the basement furnace (Picture 2) was installed without a combustion air vent. The lack of a combustion air vent on the basement furnace is allowed, but lowers this furnace's efficiency by about 10%. Both furnaces were operated. They both exhibited the proper color flame and their temperature limit switches and blower times operated properly. Their measured temperature differential exceeded the recommended 15 degrees.

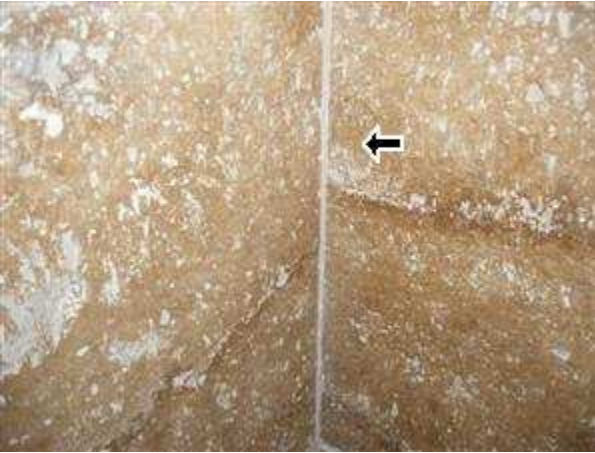
8.2 Picture 1

Bathroom walls were covered with stone and marble tile in the shower and bathtub enclosures. The tile displayed no signs of displacement or looseness. RF deep probing moisture meter readings displayed no areas of increased moisture behind the tiles. There were some minor settling cracks seen at the interior wall corners of the large shower in the master bathroom and in the smaller bathroom in the basement.

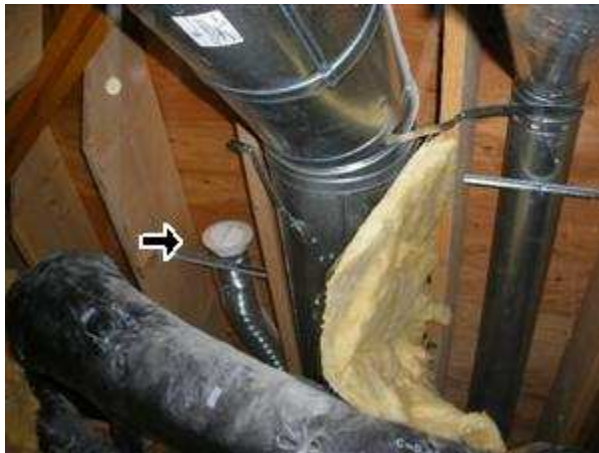
9.1 Picture 1

Bathrooms were equipped with ceiling exhaust fans which were, mostly, properly vented to the exterior. There was one bathroom (the master bathroom) where the exhaust fan appeared to be vented to the attic area (Picture 1) but given the condition and ventilation of the attic area, this did not appear to be a problem.
