WJD Decker
Home Services, LLC

Inspection Report

**Property Address:
1121 Small Street
Smallville, IL 60000**

Date: 10/2/2008	Time: 9:30 AM	Report ID: Sample Small
Property: 1121 Small Street Smallville, IL 60000	Customer: George Small	Real Estate Professional:

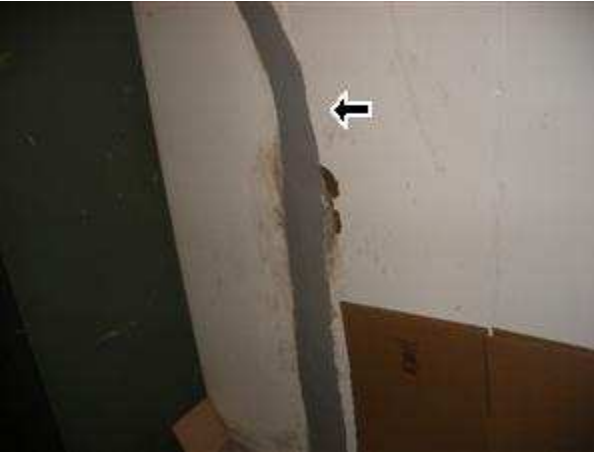
1.0 Picture 1

Foundation was poured concrete without exterior signs of cracking, efflorescence or water intrusion where observed. Interior inspection showed no signs of staining, water intrusion or efflorescence. There were a few minor cracks seen, radiating downward from the steel window pockets on the foundation wall, but these are not considered significant. There was one crack that was sealed with epoxy (Picture 1). The concrete slab displayed some minor cracking and signs of past water (efflorescence, Picture 2) but this was minor. The wall penetration for the main sewer pipe displayed some efflorescence (Picture 3) and should be sealed with epoxy.

2) RR - Recommend that the slab cracks be sealed with self-leveling polyurethane caulk.

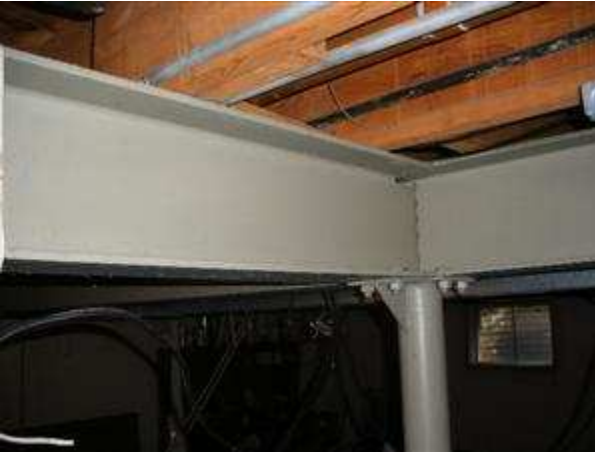
1.3 Picture 1

Structure is supported by steel girders, running east to west and a half beam (Picture 1), running north to south and supported by steel posts. The girders and posts displayed no signs of rust or displacement. The posts display no signs of rust at their bases and are not displaced.

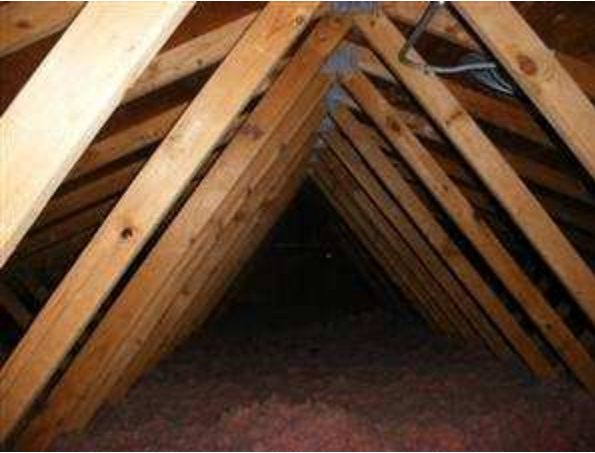
1.6 Picture 1

Attic structure was 2 x 4 wooden trusses with galvanized metal gussets in Queens truss configuration (Picture 1). The trusses were spaced approximately 24" OCD and supported exterior grade plywood roof decking. These structures displayed no signs of water staining, warp, twist or physical damage. Moisture readings were within normal limits.

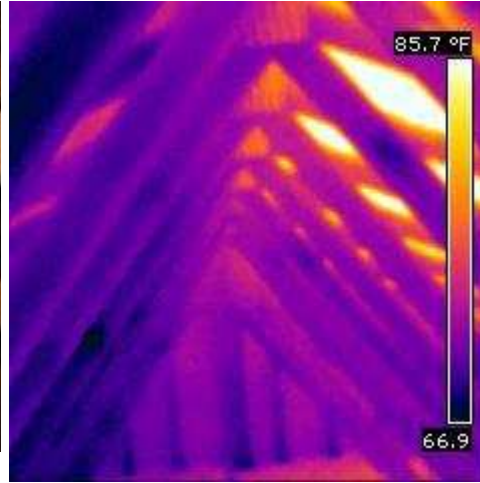
1.6 Picture 2

Thermal imaging from the attic displayed no signs of active roof leakage or excessive moisture (Picture 2).

- 1) WL - Recommend that the underside of the roof be checked every year for signs of water staining on the roof decking or rafters as an early detection method for roof leakage.

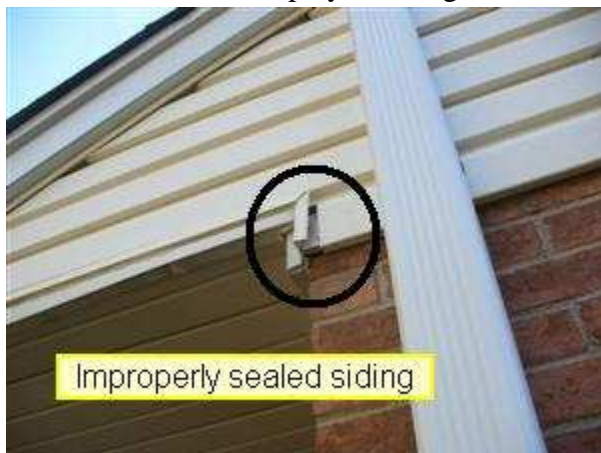
2.0 Picture 1

The exterior walls of the house were covered with vinyl siding, with the lower level covered with brick veneer with stone trim. The vinyl siding displayed no signs of physical damage and was properly secured to the house. The siding ends were properly equipped with J bar terminations. There was some small areas that displayed openings where the siding was not properly sealed (Picture 1). The brick veneer displayed some minor signs of cracking at the garage lintel (Picture 2) and was properly equipped with weep holes where it met the foundation wall (Picture 3). The limestone trim displayed no signs of cracking.

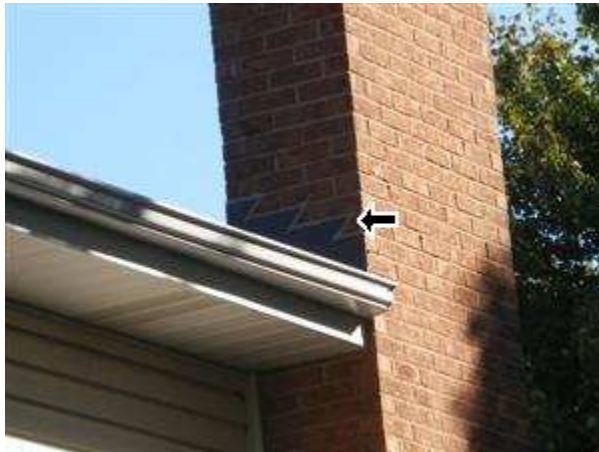
3.1 Picture 1

All roof penetrations were inspected and displayed proper flashing. The chimney was equipped with step and counter flashing (Picture 1) which was intact.

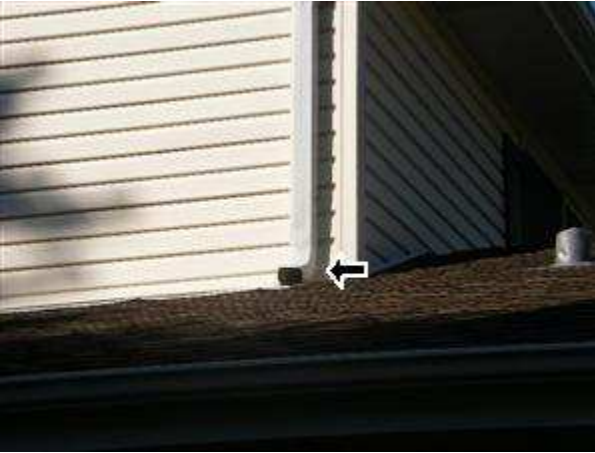
3.2 Picture 1

The roof is drained by means of metal gutters that are secured to the fascia boards by means of metal hangers. The spacing of the gutter supports meets the modern standard of a maximum of 18" spacing between supports. The gutters displayed no signs of rust or physical damage and appear to be properly sloped. There are areas where the upper sections of the gutter system drain directly onto lower roof surfaces (Picture 1). This will cause accelerated deterioration of the roof surface under these areas and greatly decrease the life of the roof. This condition will also violate the warranty conditions of most roofing material manufacturers.

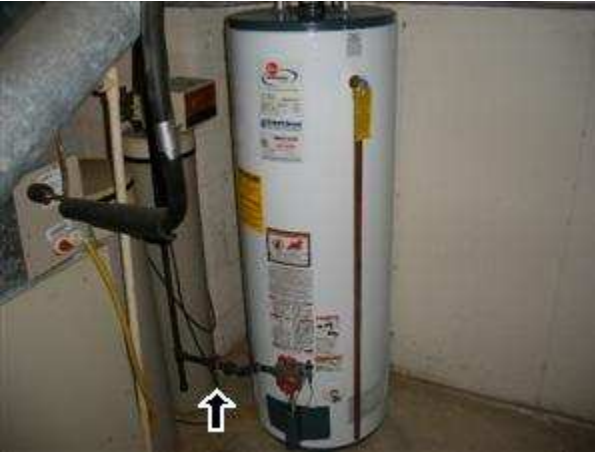
4.4 Picture 1

The water heater was properly installed with di-electric fittings. It was observed through a heating cycle and displayed the proper colored flame. The TPR valve was properly vented to an approved pipe. The water heaters vent flue was properly secured, sloped and secured to the chimney and displayed no signs of backdrafting or carbon monoxide leakage. The water heater's gas shut-off valve is indicated (Picture 1).

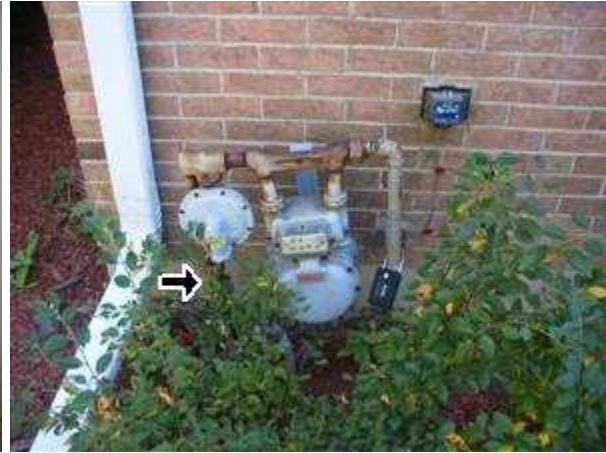
4.6 Picture 2

Main fuel (natural gas) shut-off was located on the utility meter (Picture 2).

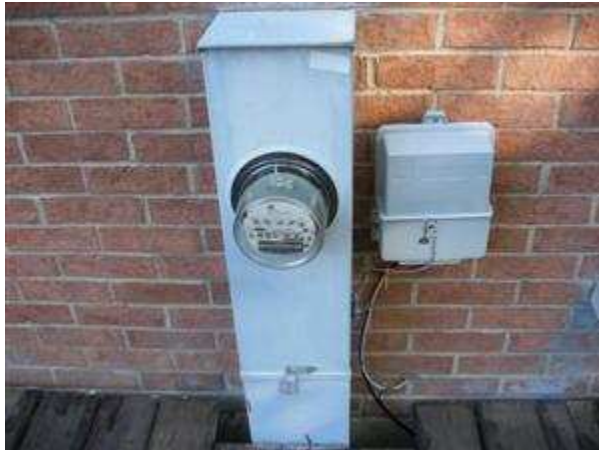
5.0 Picture 1

Electrical service is supplied by means of an underground (lateral) service drop from the utility pole to the meter box located at the rear of the house (Picture 1). The meter was rated for 200 amp service.

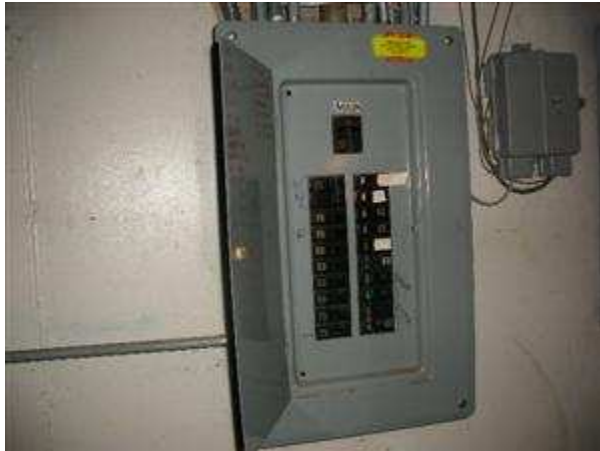
5.1 Picture 1

All raceways are metal conduit and are properly secured and bonded. The grounding conductor and the neutral conductor were properly secured to the bus and the properly bonded to the panel.

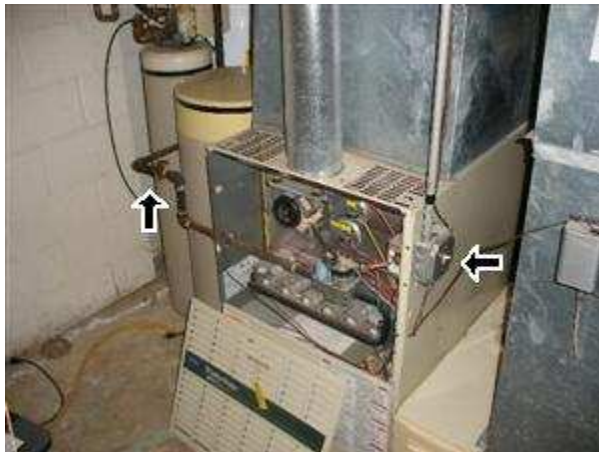
6.0 Picture 1

The subject property was heated by a Carrier category 1 mid-efficiency furnace manufactured in 1996 and located in the basement (Picture 1, gas and electrical shut-off indicated). The furnace's serial number was checked against Consumer Products Safety Commission and the manufacturer's web site for defect or recall notices and none were found.

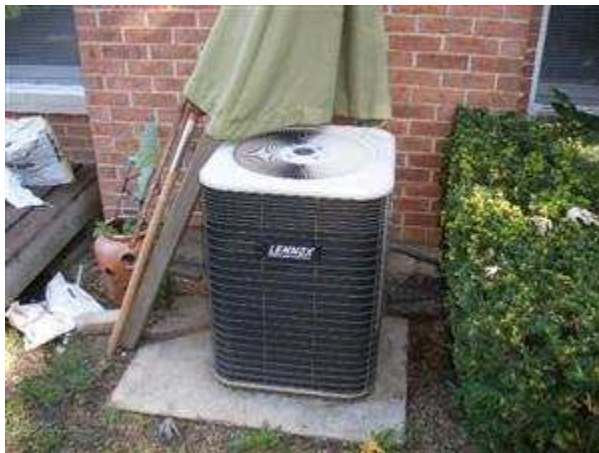
7.0 Picture 1

It is equipped with a disconnect in clear sight and not obstructed. Its gas and liquid lines were unknicked and properly insulated. The air conditioner was operated and is serviceable, delivering a differential between supply and return ducts of greater than 15 degrees.

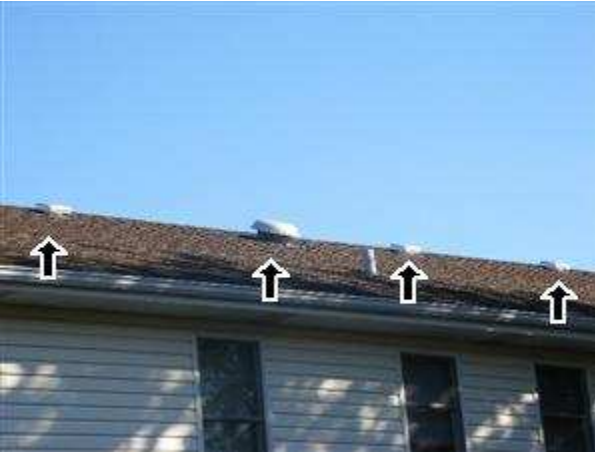
9.4 Picture 1

The attic is ventilated by a combination of soffit vents and roof vents with a power vent fan (Picture 1). The recommended baffles were not all in place (Picture 2) over the soffit vents to guard against insulation blocking the vents. There was also a power vent fan, which did not operate.
